BOUTON'S HALL CONDITIONS ASSESSMENT
FOR THE TOWN OF VIENNA

GAUTHIER
ALVARADO
ASSOCIATES

06.28.2018

Bouton's Hall Conditions Assessment

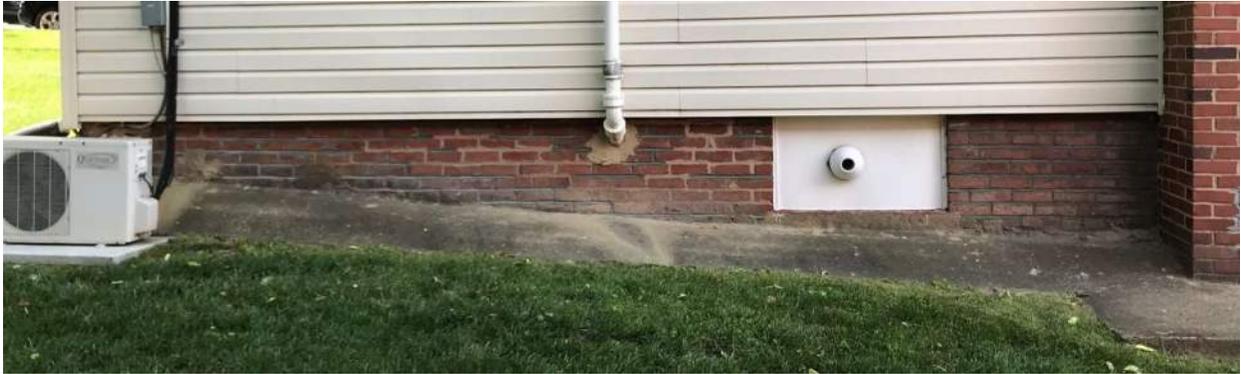
In general, the building envelope appears to be well maintained. There is evidence on the Northwestern elevation that the brick foundation was recently repointed, as there are mortar joints with a different coloration than the original mortar joints as shown above.

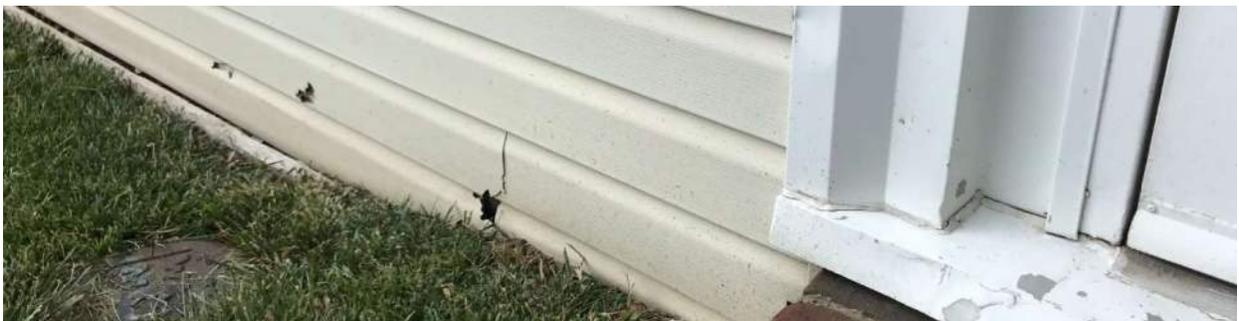
The current owner believes the vinyl siding is thirty years old. There are locations, as shown above, where the vinyl siding has been damaged. Since the vinyl siding is installed over the original exterior finish, we were unable to assess the condition of the original finish.

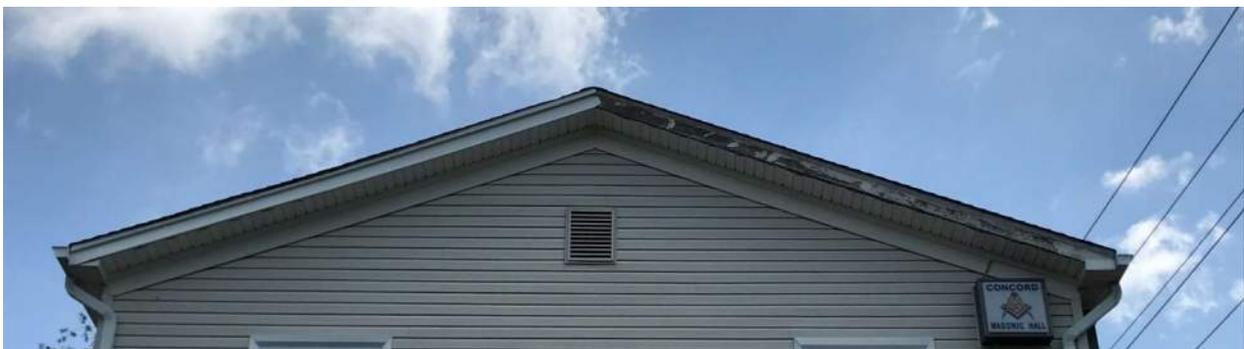
There are also several locations on the exterior where trim covering is missing, as shown above.

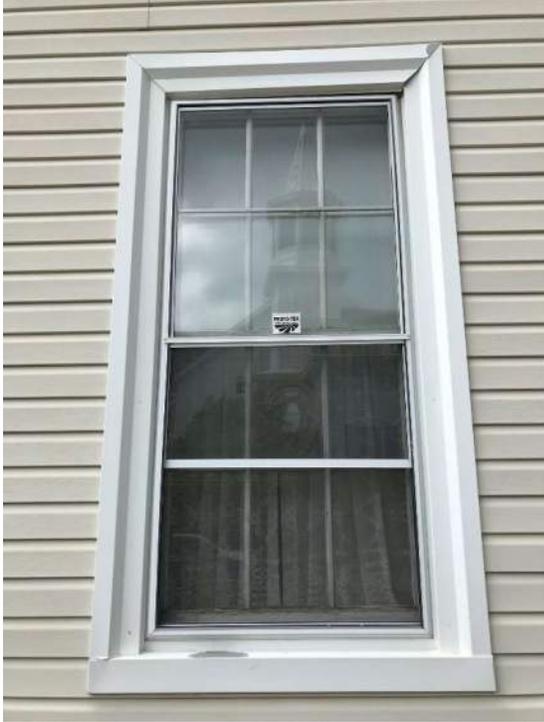
In other areas, the trim finish is failing, as shown in the upper right-hand corner and on the sill of the window to the left.

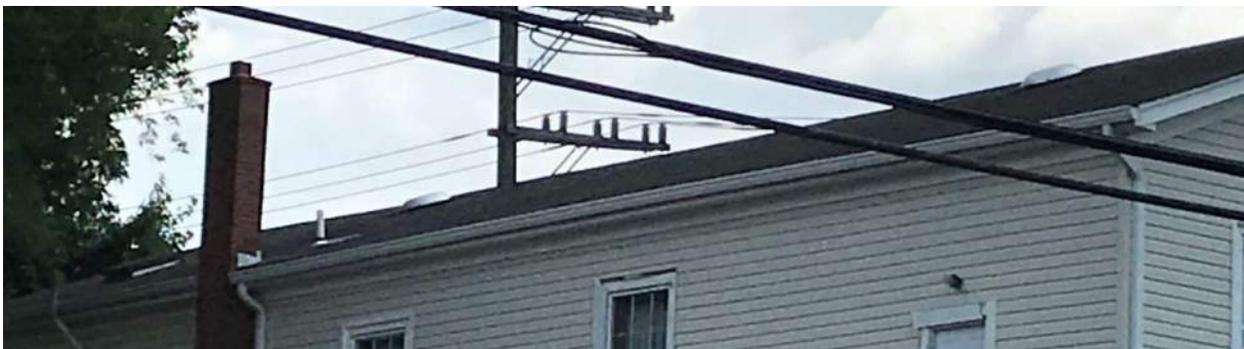
We noted four roof penetrations as indicated in the image below: three vents and one roof access hatch. The condition of these roof penetrations will need to be assessed prior to reroofing, as they may need to be replaced as well.

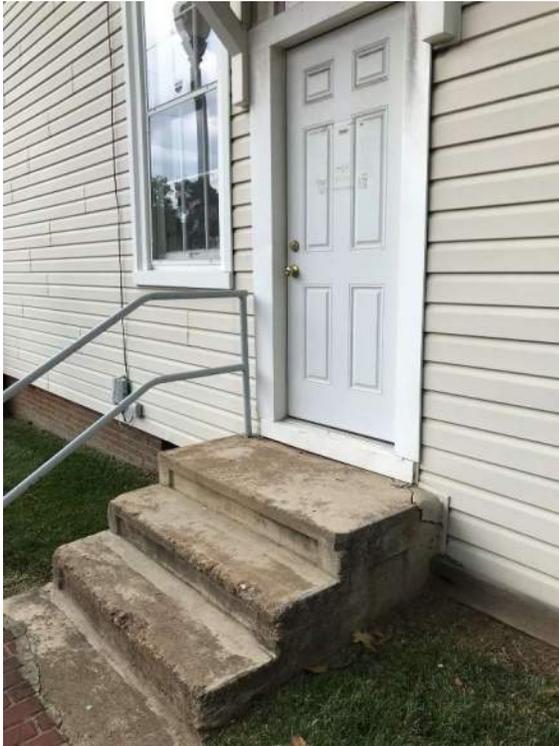
In addition, the exterior landing for the second exit from the main level (shown to the left) is not appropriately sized.

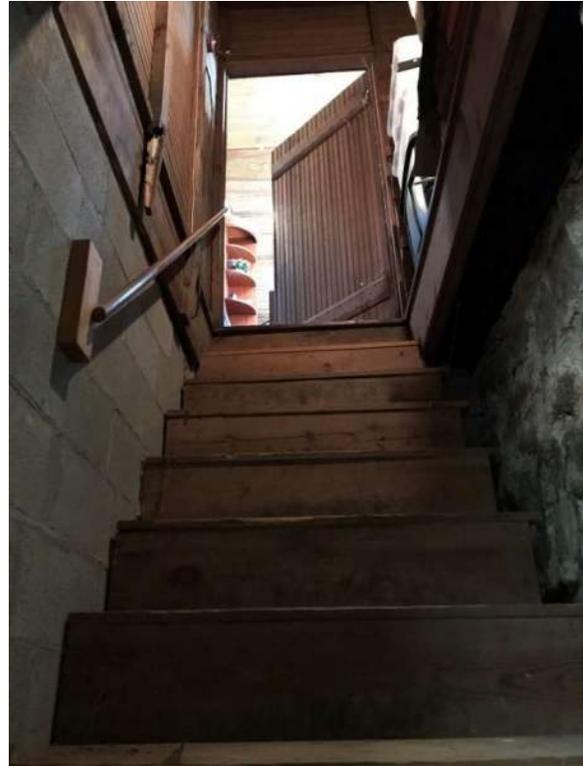
The stair to the basement on the North side of the building (shown to the right) is lacking several elements required by code, including a landing on the inside of the door at the top of the stair, handrail extensions, a proper number of brackets, a continuous handrail, there are risers that exceed the maximum height allowed and the riser height is not consistent across the entire flight of the stair, to name a few.

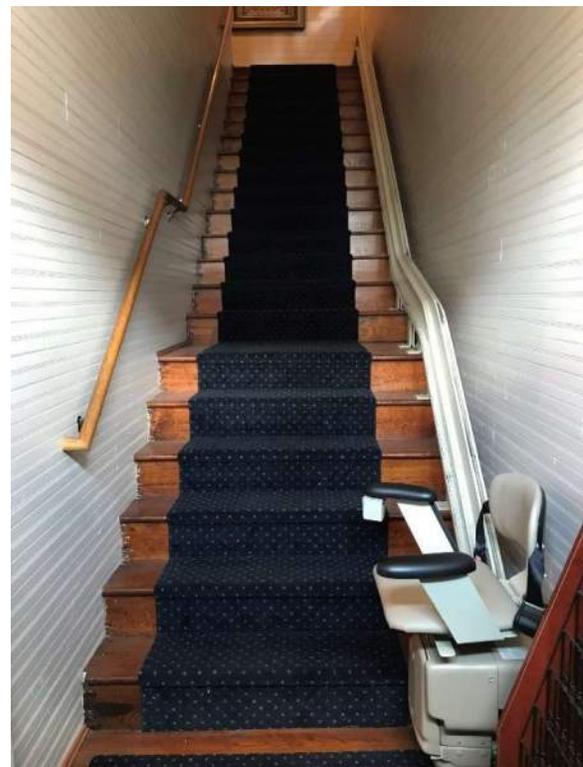
Continuing onto the main stair on the North side of building (shown to the right), there are several deficiencies, including: the lack of handrail extensions, and risers that exceed the maximum height allowed per code.

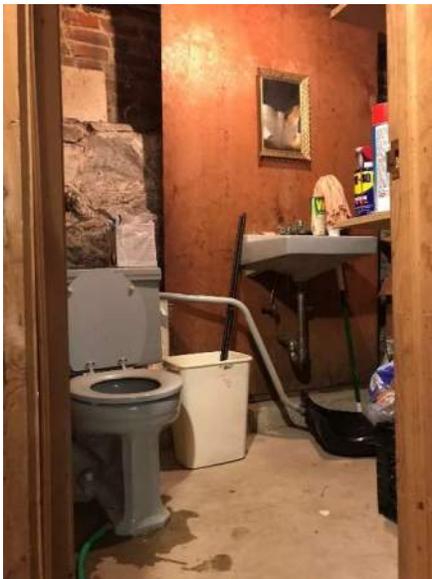
The basement restroom, tucked in the corner behind the stairs, does not have the proper clear entrance opening, does not have the proper clearance at the fixtures, accessories are either not there or at the wrong heights and piping is not protected. If the basement is to become accessible in the future, this restroom would need to be completely renovated.

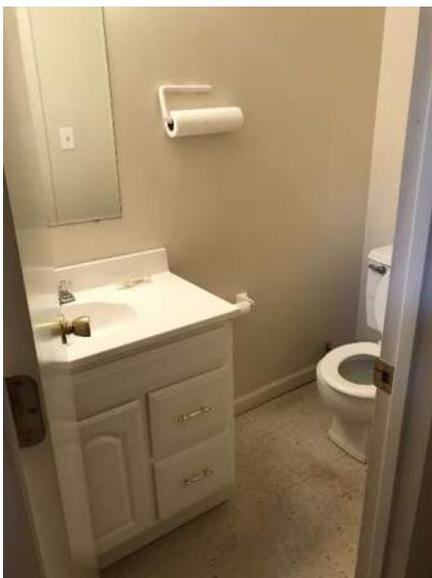
On the first floor at the North end of the building, the door is too narrow for a proper clear opening, the fixtures do not have the proper clearances, accessories are either not there or at the wrong heights and the faucet controls are not accessible.

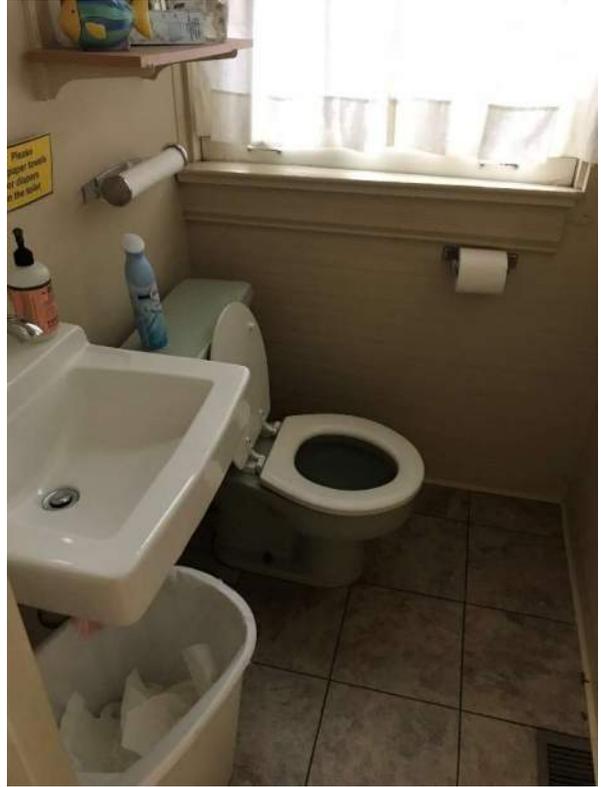
The first floor restroom in the current retail space is too narrow to allow for proper clearances at the fixtures. The door is too narrow for a proper clear opening, and accessories are either not there or at the wrong heights.

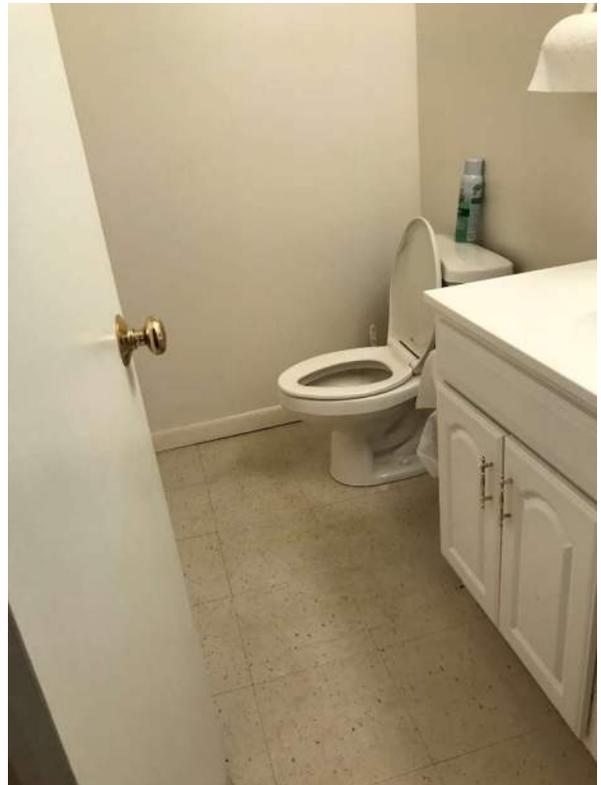
The second floor, similar to the first floor, has a door too narrow for a proper clear opening, the fixtures do not have the proper clearances, accessories are either not there or at the wrong heights and the faucet controls are not accessible.

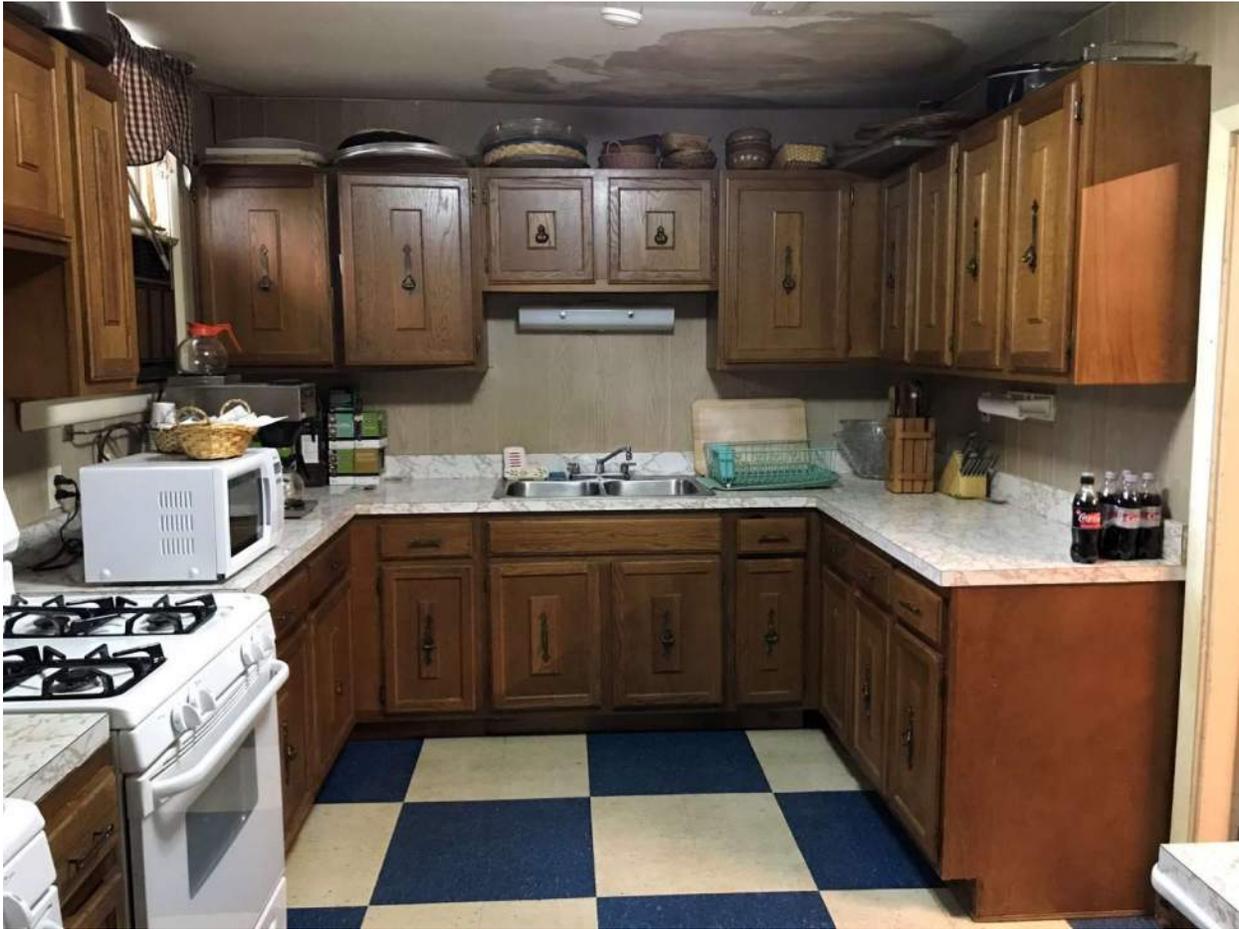
The existing kitchen does not meet accessibility requirements in its current configuration.

The existing base cabinets in the kitchen exceed the maximum allowable height.

The kitchen sink should allow for a forward approach since cooktops are provided. The ovens will require a work surface for forward approach adjacent to one side of the oven door.

The refrigerator may need to be replaced to meet accessibility.

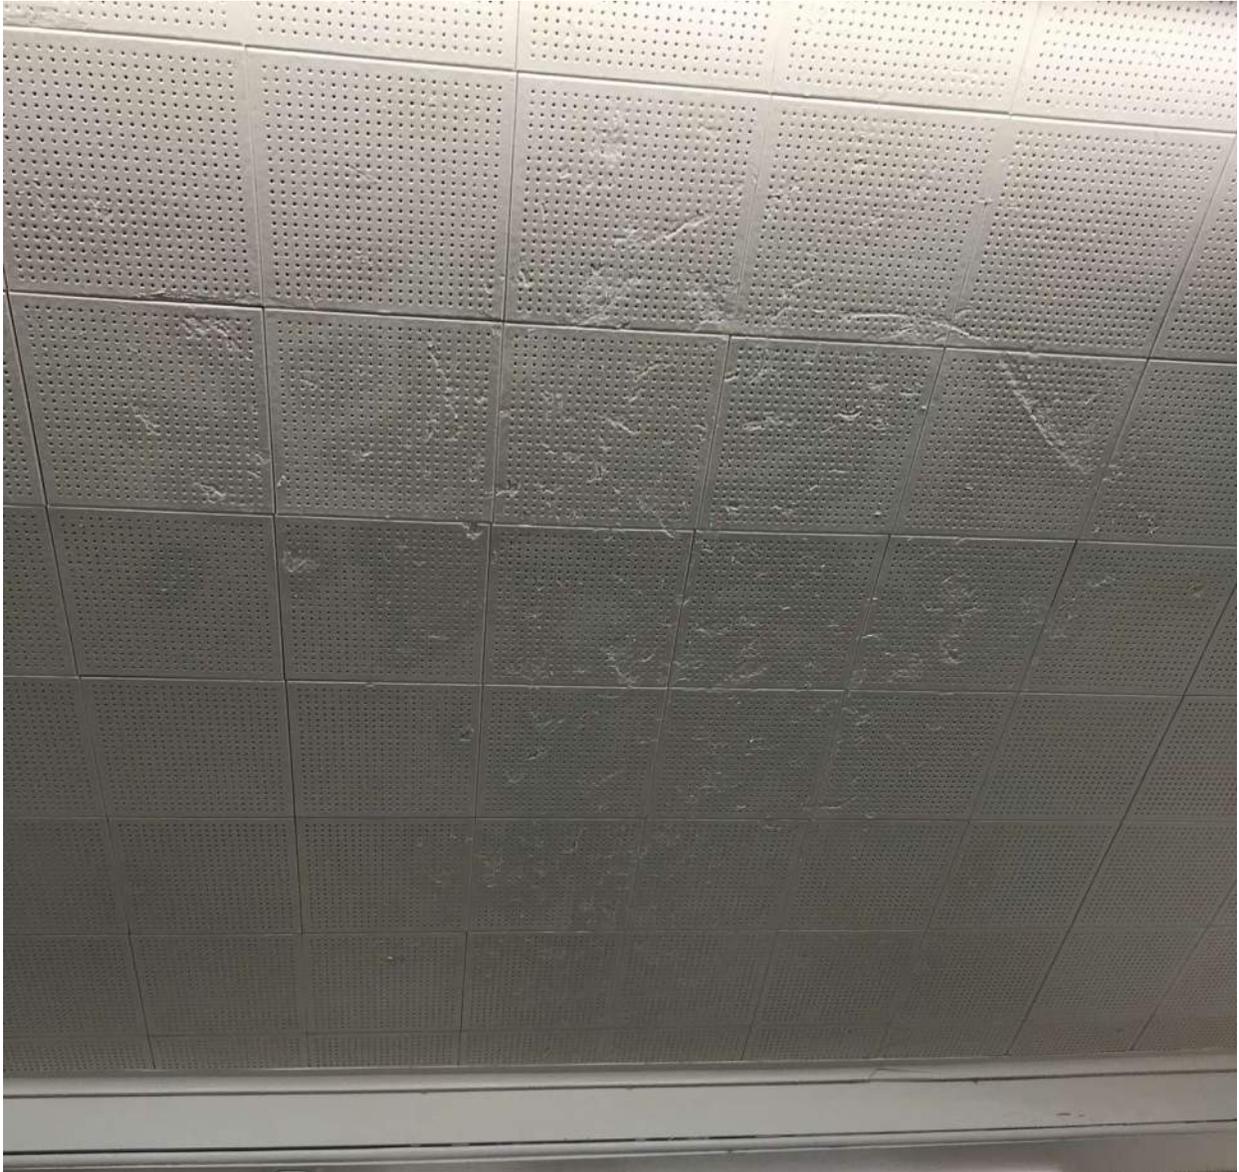
The picture above shows the ceiling at the work area beyond the retail space on the first floor. There appears to be a certain degree of water damage on the ceiling panels.

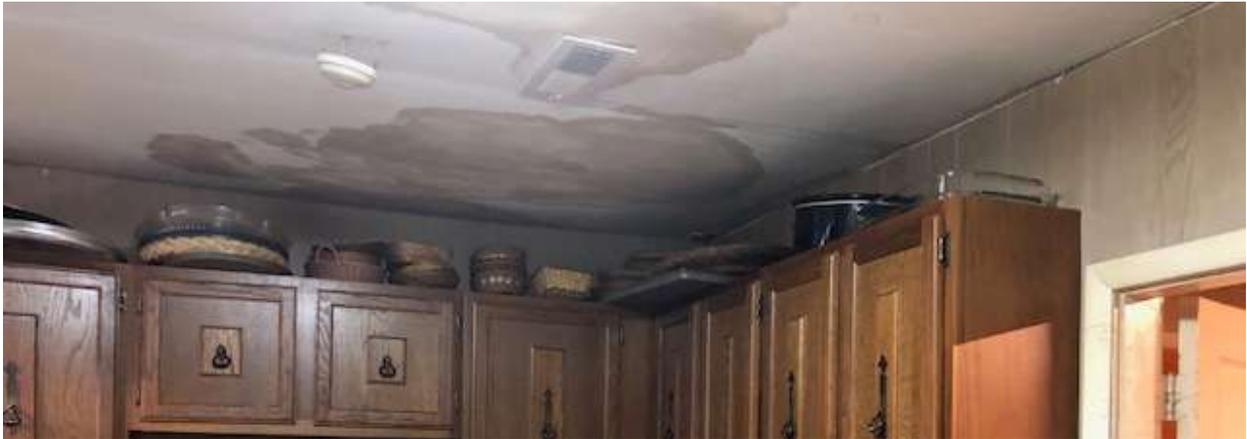
The picture above shows the kitchen ceiling on the second floor. It is evident that there is water damage.

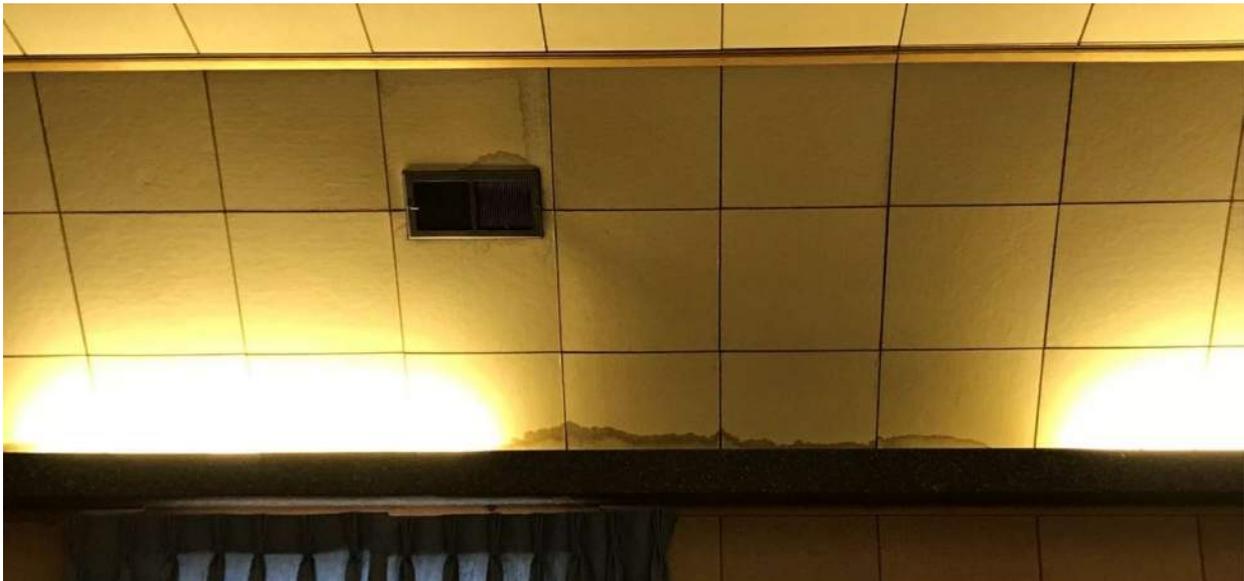
The picture above shows a portion of the ceiling in the assembly space on the second floor. This portion of the ceiling is on the Southeastern Elevation adjacent to the kitchen area. It is evident that there is water damage.

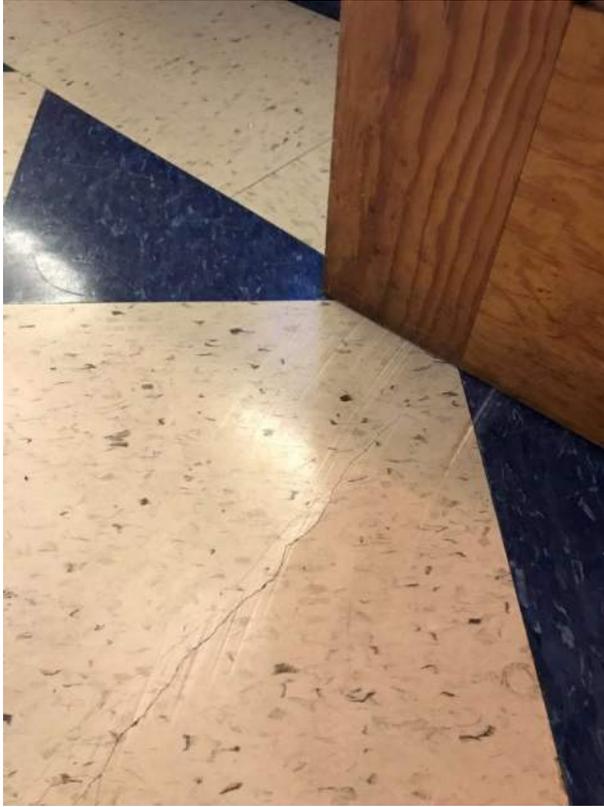
It appears that some of the structure beneath the floor finish and subfloor is telegraphing through. This is evident in the image to the left where the existing floor finish is slightly raised and is rubbing against the bottom of the door leaf, causing the floor finish to crack. This may be alleviated by increasing the number of floor joists or replacing the subfloor.

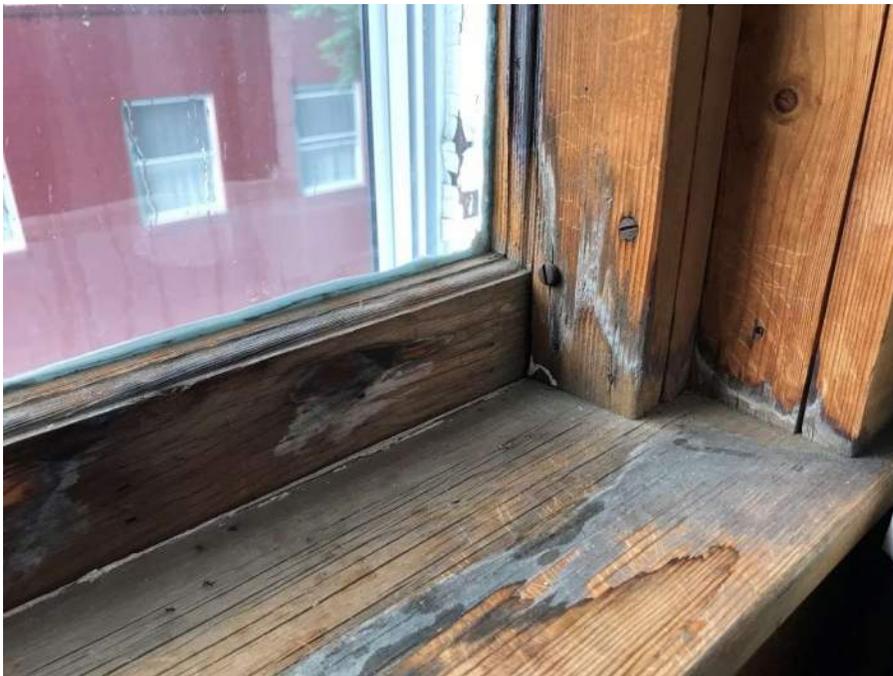
Most of the double-hung windows on the second floor show evidence of water damage. This particular window is located on the Northwestern elevation near the entry to the assembly space on the second floor. It has not been determined if this water damage is recent or has been repaired with existing finishes.

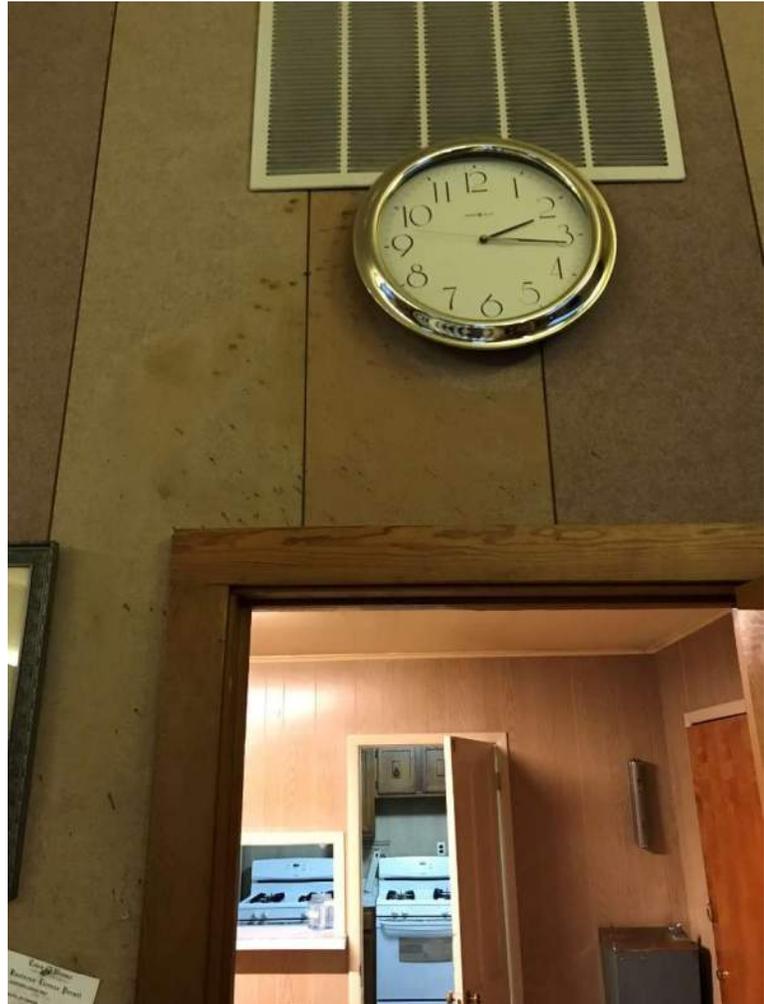
There is evidence of water damage on a wall in the second floor assembly area, as shown in the image to the right. This wall is located adjacent to the kitchen area. Due to its proximity to an air intake vent, it is possible that water could have penetrated the wall finish from the vent directly above.

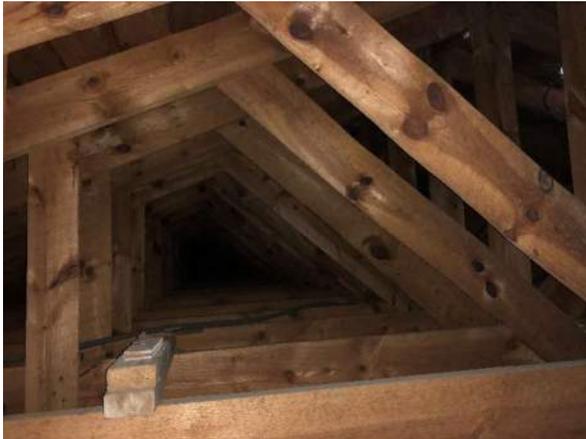
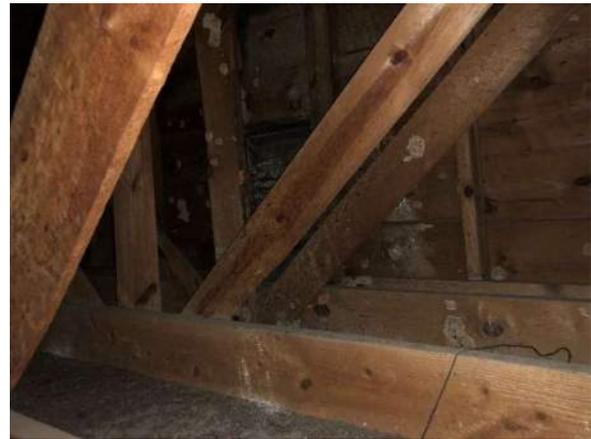
There is visible evidence that some of the floor joists have been damaged by termites. These have been reinforced by sistering joists on each side of the damaged joists. We are unable to determine if the termites are still active. The majority of the floor framing for the first and second floor are covered. We recommend that a pest control service be employed to do a thorough pest inspection.

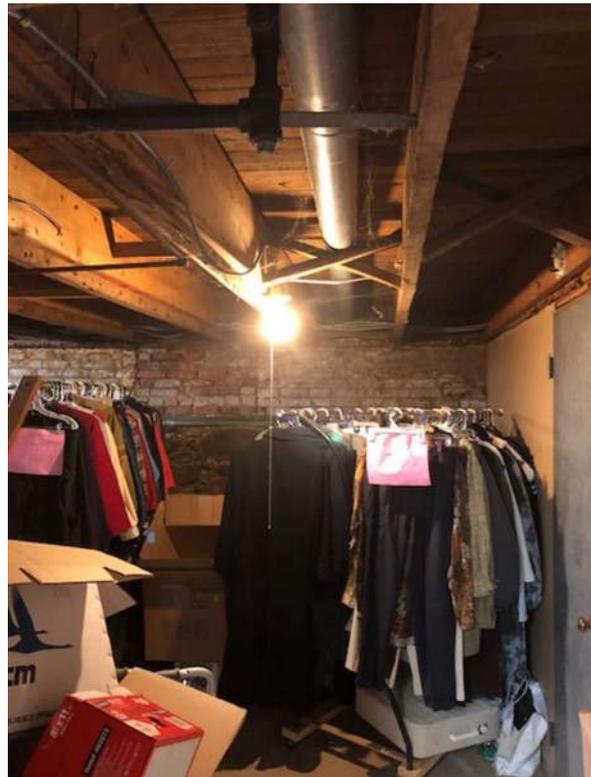
It was brought to our attention that there is a foundation leak at the Northeast end of the building. We noticed some evidence of moisture entering the building during our site visit, but, did not notice any active foundation leaks. An evaluation was performed and three recommendations were made to remedy the problem. We recommend that these options be evaluated during the next phase of this project.

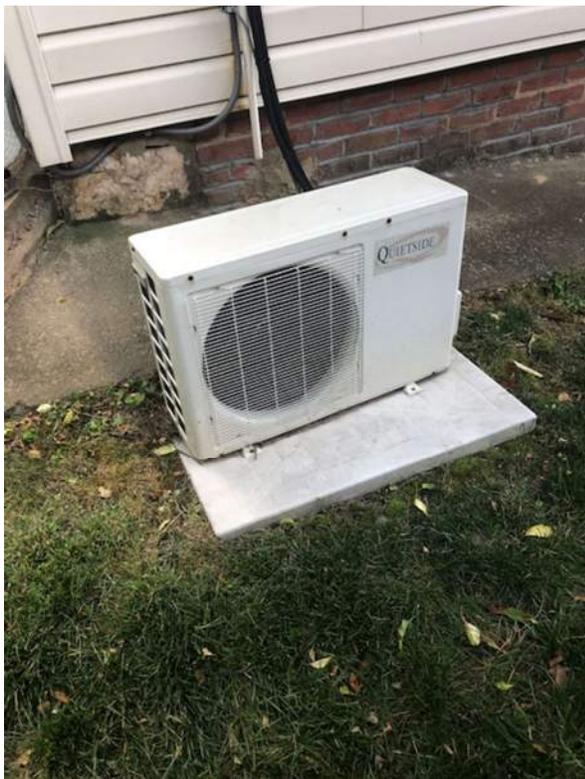
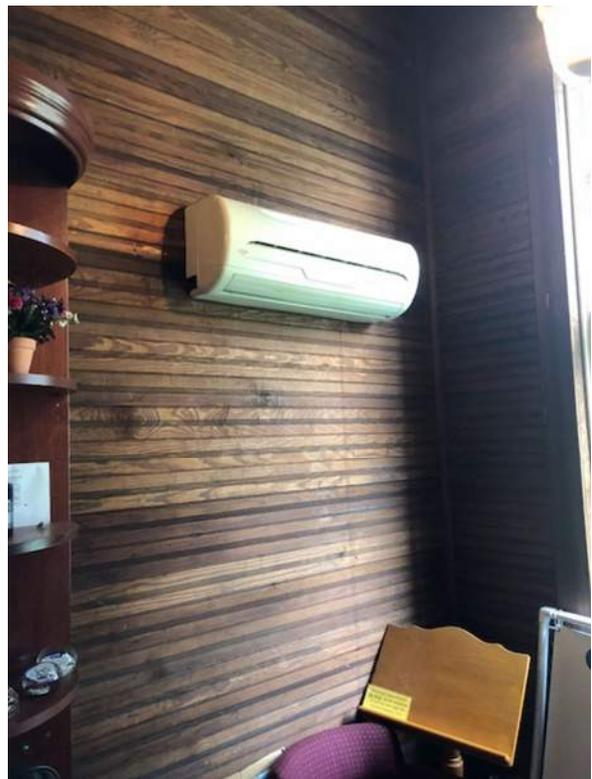
The Masonic Meeting space is also air conditioned by a 5-ton split DX system with remote air cooled condensing unit located at the rear of the building. The indoor fan and coil is located in mezzanine like space above the kitchen. Access to this unit for service requires a ladder and somewhat difficult. There is also one window type A/C unit in the meeting room, one window type A/C unit in the kitchen and one mini split DX A/C unit in the office. If an addition goes out the back, this condensing unit would need to be replaced.

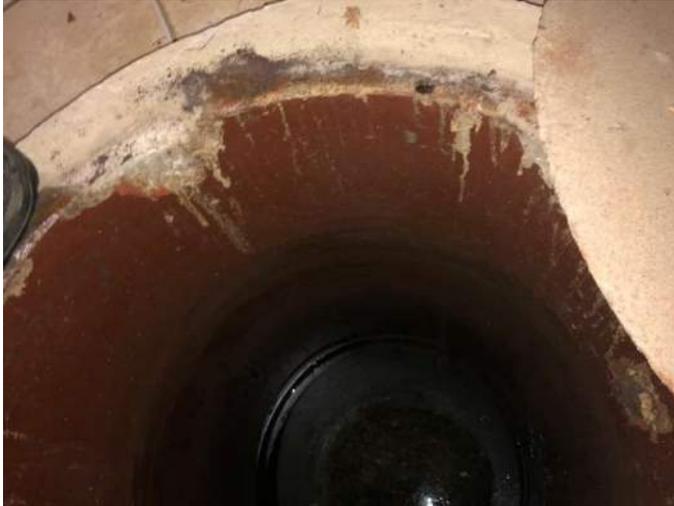
In the basement, next to the stairs, there is a two-foot diameter concrete pit that is approximately six feet deep. The pit includes a steel plate cover and is partially full of what appears to be clean water. The bottom of the pit is gravel. We were unable to determine what the pit is for. Possibly a sump pit, but there is no permanent pump. It was also suggested that it was once a well and has since been abandoned and filled with gravel. In any case, the Town should have this pit

explored in more detail and have it filled or locked shut if it serves no purpose. It is currently considered a safety hazard as the steel top is equipped with a handle and can be easily removed. At a minimum, the top should be secured.

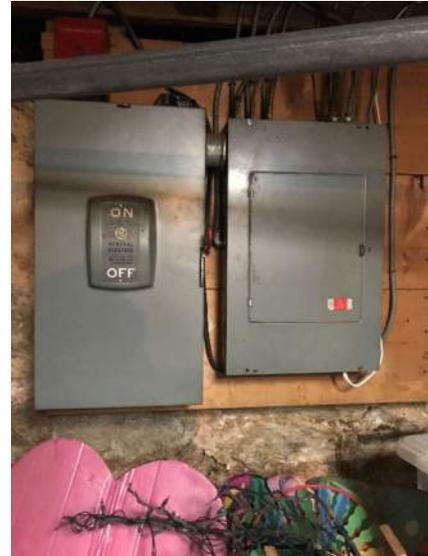
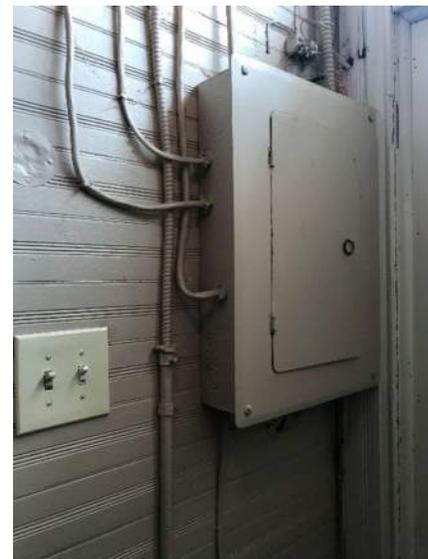
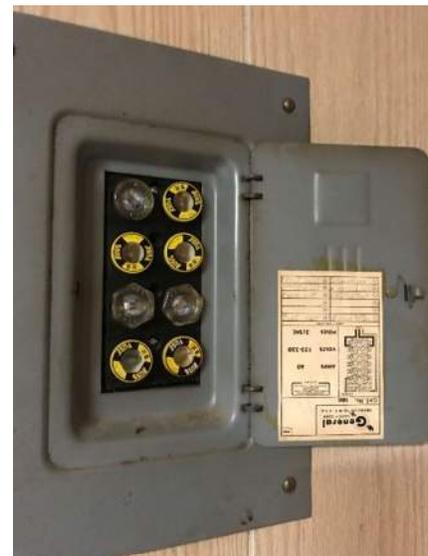
For code compliance, 3 feet of clearance shall be provided in front of any/all electrical equipment. Currently, the main service disconnect and panel in the basement is blocked by storage. There are also a number of junction boxes throughout the space that require covers.
