## **ARCHITECTURAL BUILDING CODE SURVEY**

# **TOWN OF VIENNA PARKS AND RECREATION FORMER FAITH BAPTIST CHURCH**

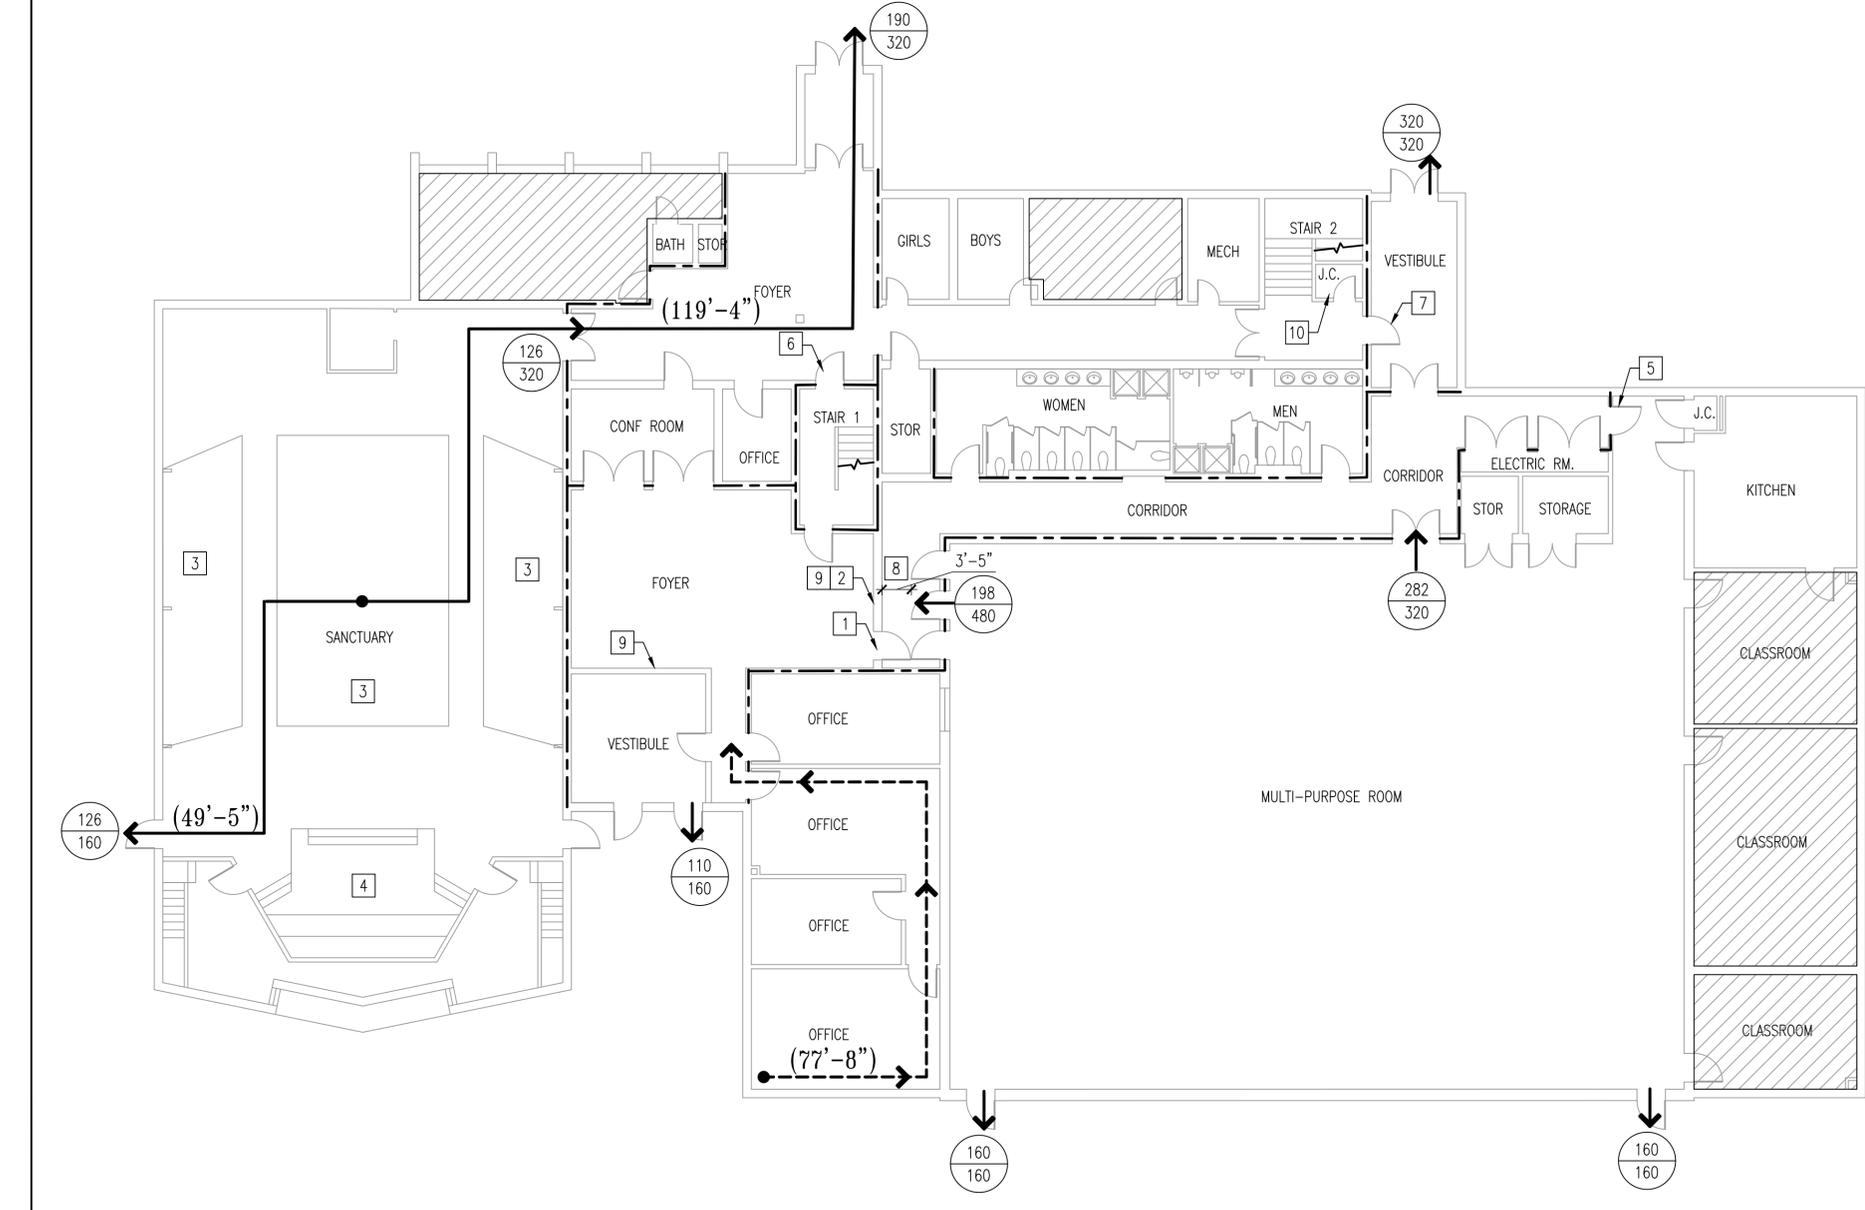
1 LIFE SAFETY - FIRST FLOOR PLAN  
G-101 SCALE: 3/32" = 1'-0"

As mentioned above and noted on the plans, there is an issue at the southeast corner of the multi-purpose room. One of the three doors is a required means of egress based on capacity. The two single doors to the exterior and the double doors to the corridor can provide egress capacity for 640 people. One of the three doors would provide the 160-occupant capacity necessary to provide for the posted occupant load of 800 for the room. The single door into the foyer across the corridor from these doors is therefore also required to maintain the capacity out of the multi-purpose room. However, this door is required to swing into the foyer instead of the corridor, and the corridor at this point is also too narrow. Where the existing doors swing out of the multi-purpose room, there must be a minimum of 48" plus the swing of the door, or else the doors must swing away from each other. Since other code requirements require both sets of doors to swing in the same direction, the 48" must be maintained.

Field surveys noted that there are janitor's closets on both stories of the stair adjacent to the Boiler Room. Egress stairs are not permitted to have any other rooms or storage within them, except in very limited cases and with specific fire-ratings on those spaces. These janitor's closets do not meet such criteria.

- The first is the wall that separates the front foyer from the multi-purpose room. As noted previously in this report, this wall is too close to the doors leading out of the multi-purpose room, and a second door is needed in the wall to meet the egress capacity requirements from the multi-purpose room.
- The second is the wall subdividing the front lobby into a foyer and vestibule. The way this wall is configured, it lengthens the travel distance from the front office to a point where there are two paths to exit the building. Without the wall, that path would be right at the limit to meet code, but as constructed that path now exceeds the code limit (as shown on the attached plans).

- 1 DOOR NOT PERMITTED TO SWING TOWARD THE MULTIPURPOSE ROOM.
- 2 ADDITIONAL DOOR IS REQUIRED IN THIS WALL TO MEET MINIMUM REQUIRED EGRESS CAPACITY.
- 3 SANCTUARY SEATING - BENCHES WITH OCCUPANT LOAD CALCULATED AT 1 PER 18" OR BENCH LENGTH.
- 4 EXISTING STAGE WITHOUT PROSCENIUM (ALTAR).
- 5 NOT A REQUIRED MEANS OF EGRESS
- 6 OCCUPANT LOAD FROM SECOND STORY = 31. EGRESS THROUGH FOYER.
- 7 OCCUPANT LOAD FROM SECOND STORY = 31. EGRESS THROUGH VESTIBULE.
- 8 MINIMUM 48" CLEAR FROM DOOR OPEN AS SHOWN TO OPPOSITE WALL NOT MET.
- 9 EXISTING WALLS DIVIDE WHAT APPEARS TO HAVE BEEN A RATED EGRESS CORRIDOR.
- 10 JANITOR'S CLOSET (OR ANY STORAGE OR OTHER FUNCTION) NOT PERMITTED IN STAIRWELLS.
