## **ARCHITECTURAL BUILDING CODE SURVEY**

### **TOWN OF VIENNA PARKS AND RECREATION FORMER FAITH BAPTIST CHURCH**

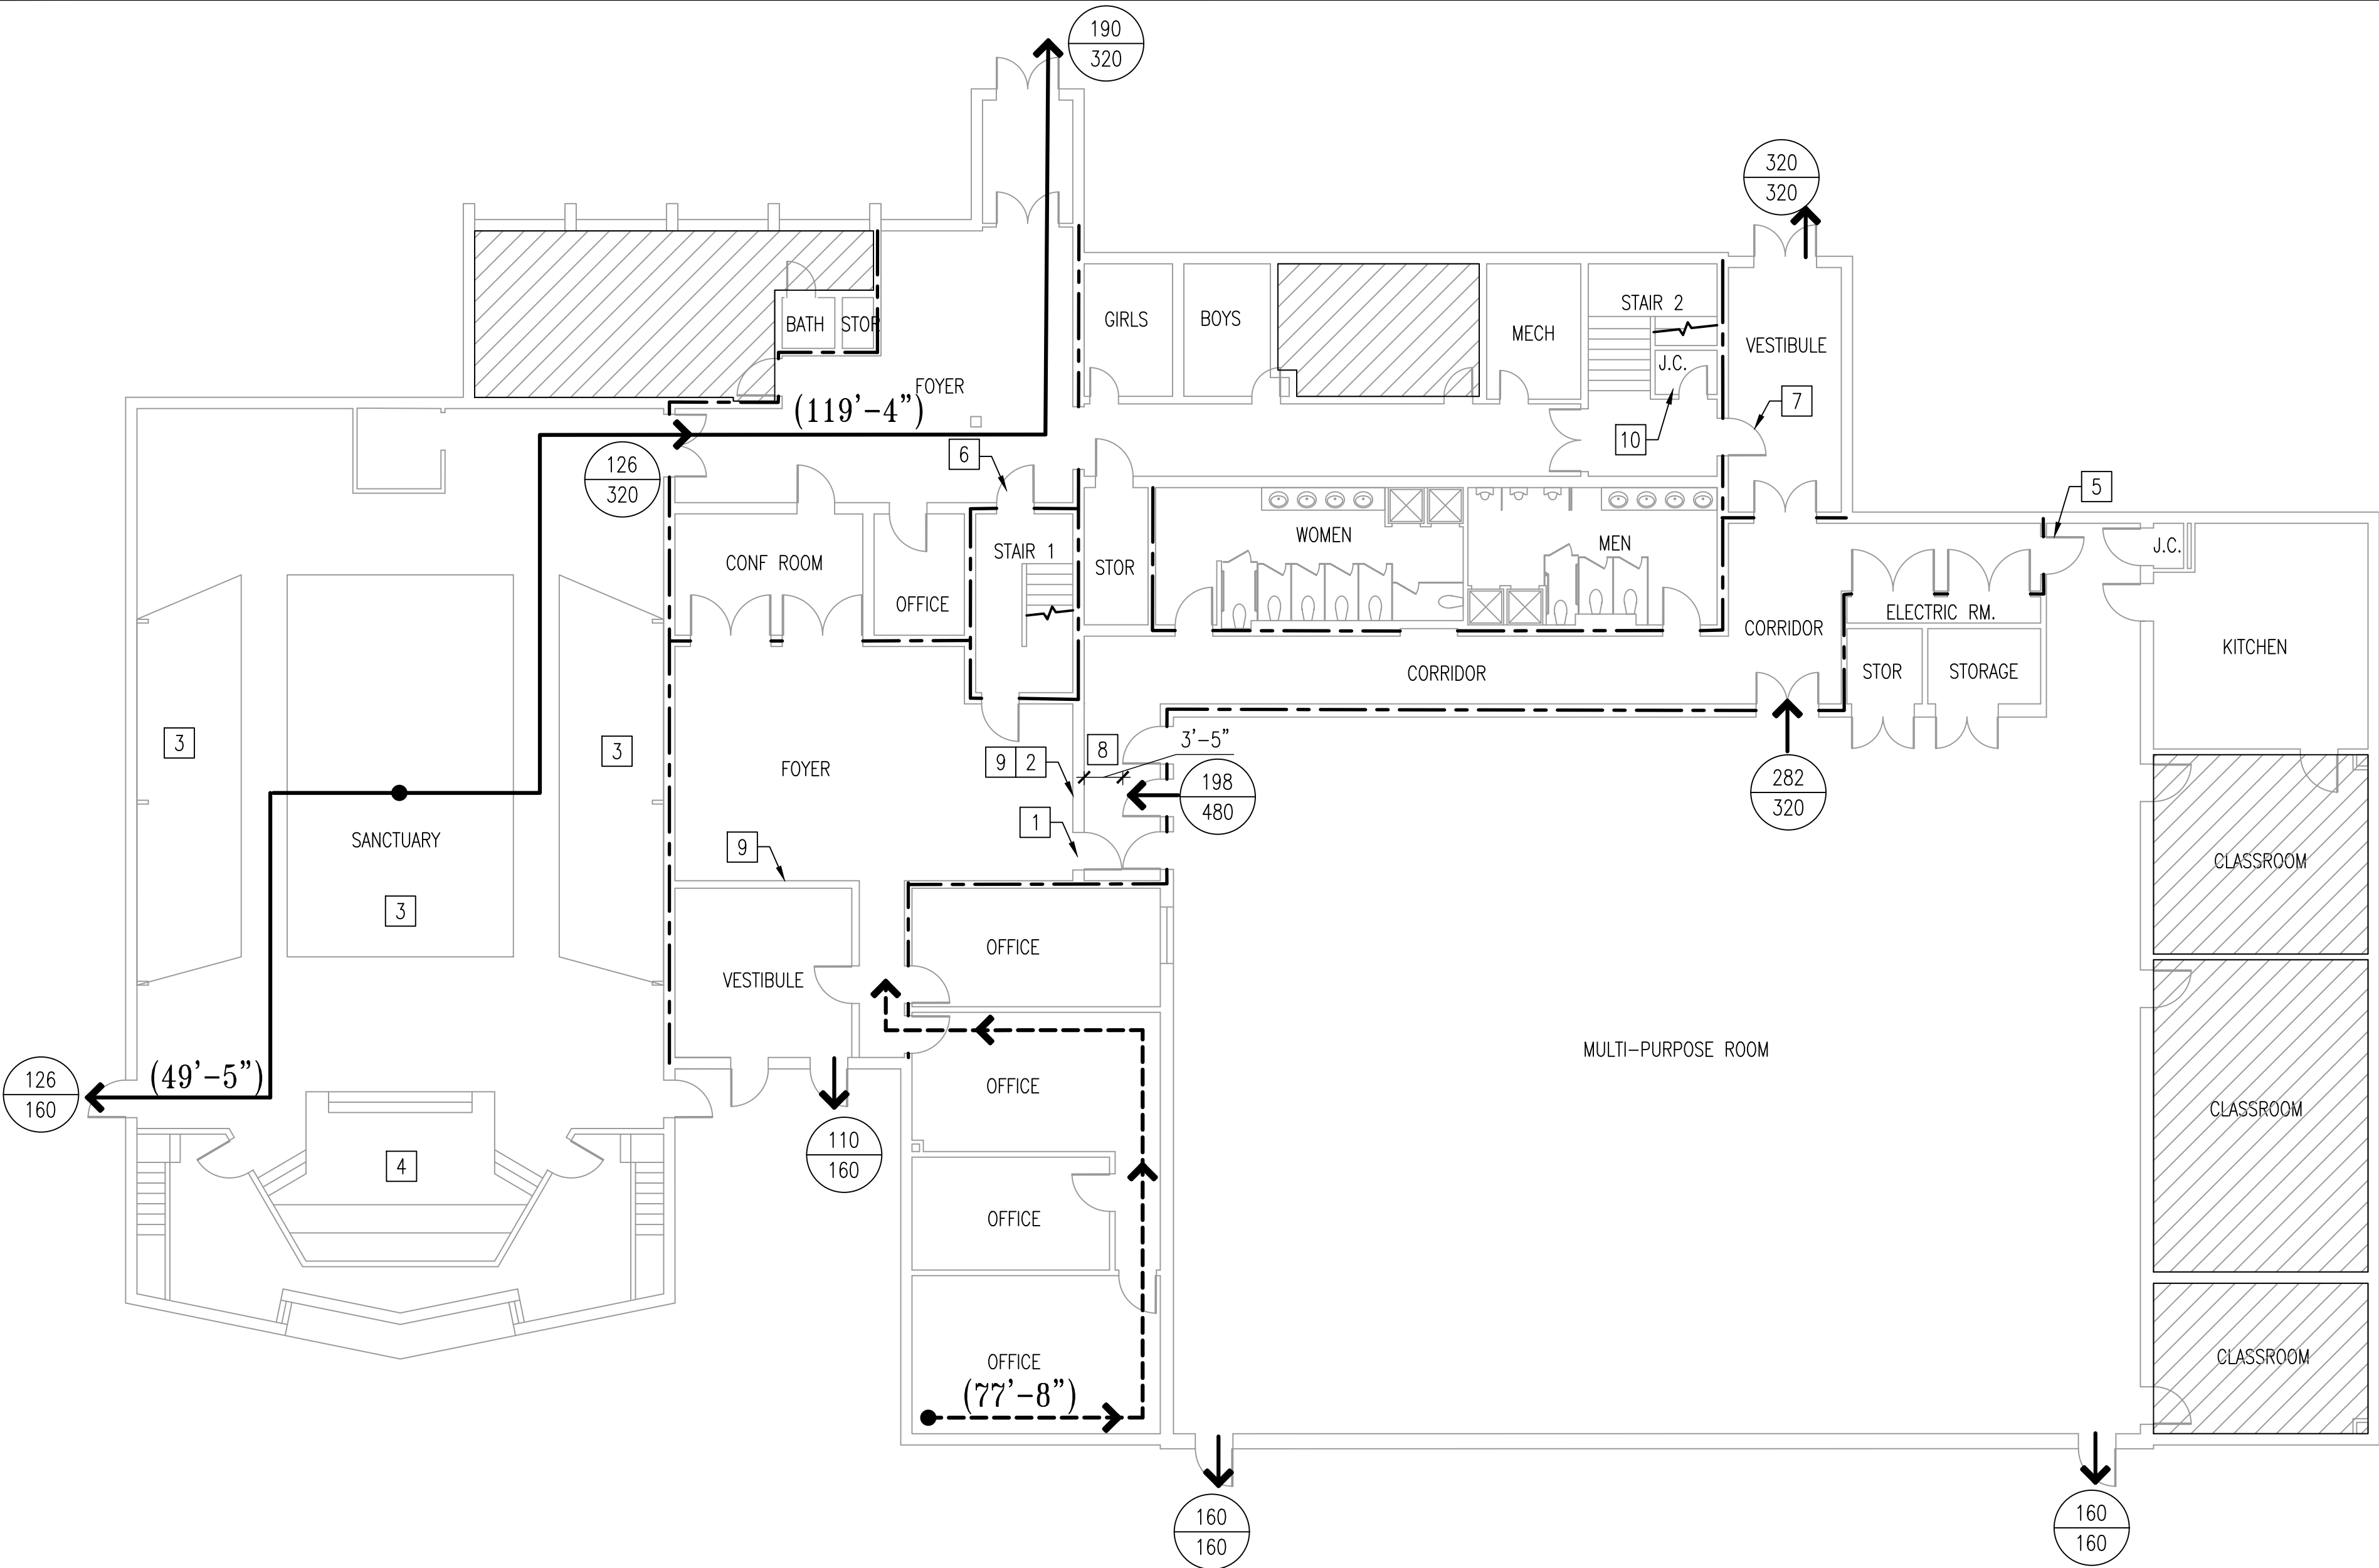
1 LIFE SAFETY – FIRST FLOOR PLAN  
G-101 SCALE: 3/32"=1'-0"

Exit access is defined as the route(s) through the building from an occupied space to an exterior door. The code sets limits on the length of the exit access (travel distance) and sets requirements for protection of the exit access. Because the existing building has no sprinkler system throughout, the allowable travel distances and protection requirements are more restrictive. Total travel distance from any location in the building to an exit is limited to 200 feet. The building is compliant in this respect. Travel distance from any point in the building to a point where two discernable paths to exits are available is limited to 75 feet. As noted on the attached drawings, the path from the front offices just exceeds this limit.

As mentioned above and noted on the plans, there is an issue at the southeast corner of the multi-purpose room. One of the three doors is a required means of egress based on capacity. The two single doors to the exterior and the double doors to the corridor can provide egress capacity for 640 people. One of the three doors would provide the 160-occupant capacity necessary to provide for the posted occupant load of 800 for the room. The single door into the foyer across the corridor from these doors is therefore also required to maintain the capacity out of the multi-purpose room. However, this door is required to swing into the foyer instead of the corridor, and the corridor at this point is also too narrow. Where the existing doors swing out of the multi-purpose room, there must be a minimum of 48" plus the swing of the door, or else the doors must swing away from each other. Since other code requirements require both sets of doors to swing in the same direction, the 48" must be maintained.
