Pre-Demolition Asbestos-Containing Materials Survey Report

**Town of Vienna Existing Faith Baptist Church Building
301 Center St S
Vienna, VA 22180**

July 24, 2023

JSK Project Number JSK-2023-48

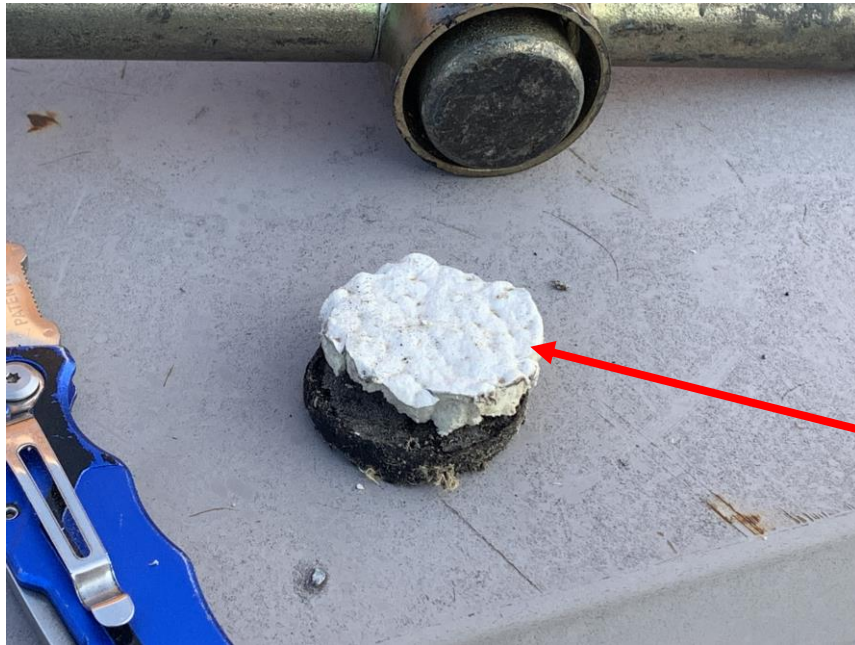
Homogeneous Material No. 1 – Non-ACM Built-up Roof Field with yellow insulation located on the building roof (flat part).

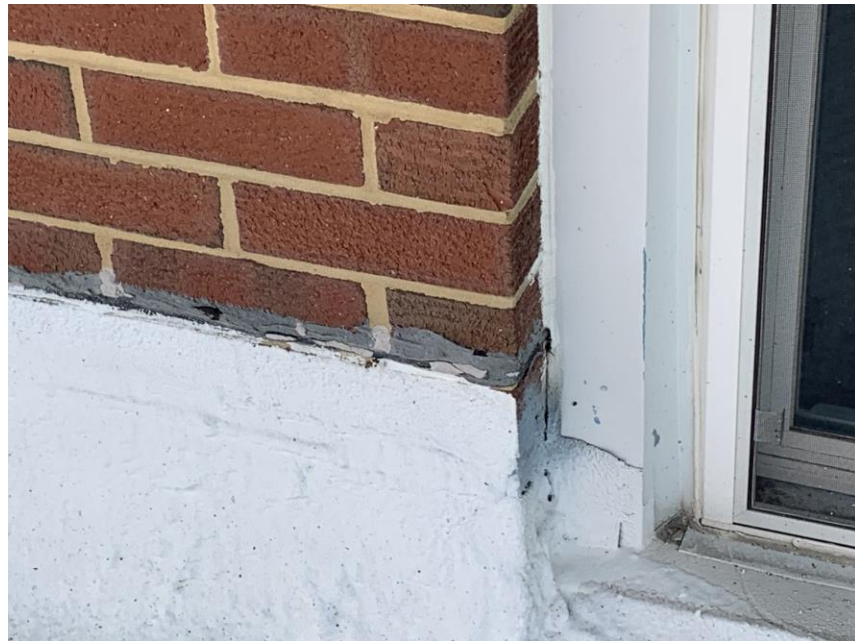
Homogeneous Material No. 2 – Non-ACM Black Roof Flashing Caulk located on building roof (flat part).

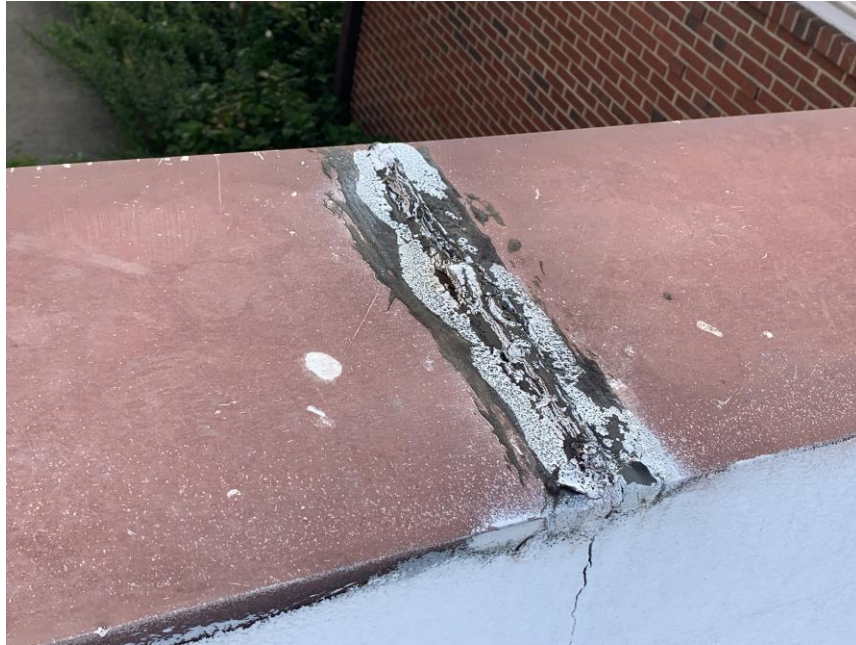
Homogeneous Material No. 3 – Non-ACM Black/Gray Parapet Wall Cap Caulk located on Shingle Roof over the Sanctuary.

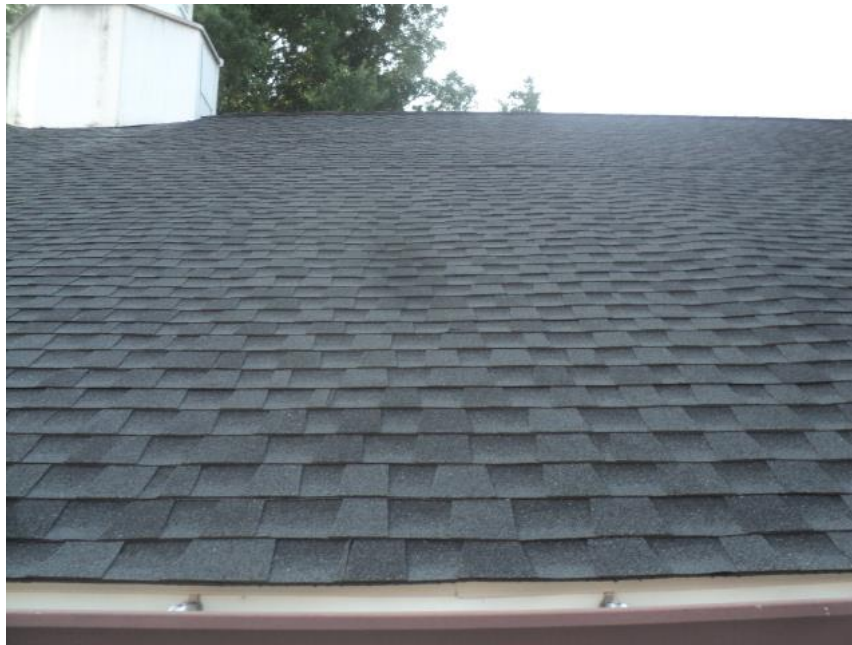
Homogeneous Material No. 4 – Non-ACM Black Asphalt Shingle with Black Felt Paper located on Shingle Roof over the Sanctuary.

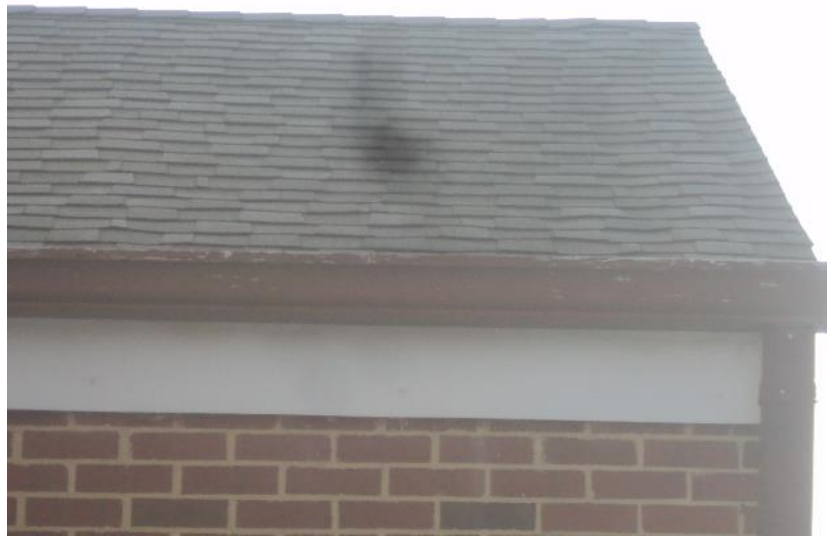
Homogeneous Material No. 5 – Non-ACM Black Asphalt Shingle with Black Felt Paper located on Shingle Roof over Original Building Construction.

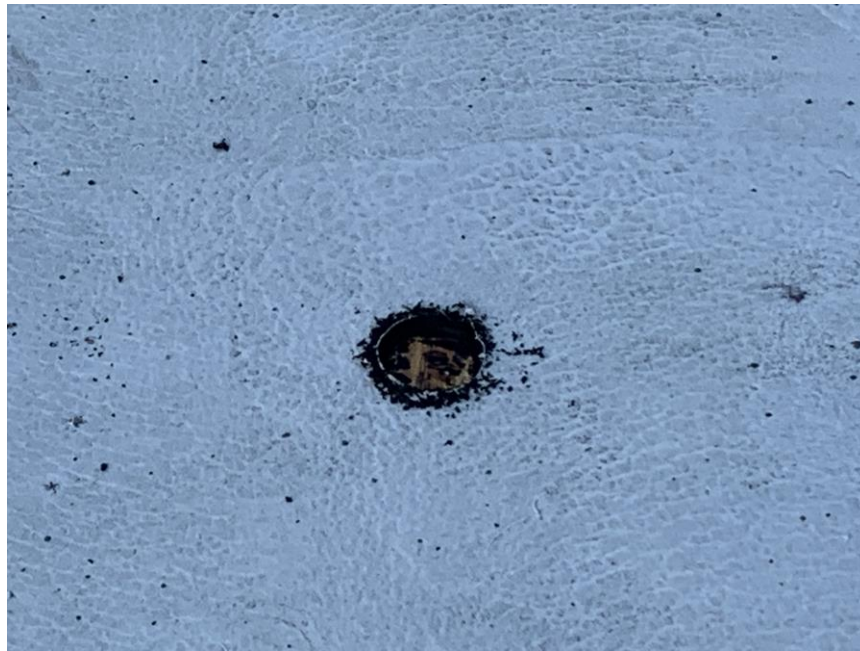
Homogeneous Material No. 6 – Non-ACM Built-up Black Asphalt Roof Field located on Portico flat roof at rear of the building.

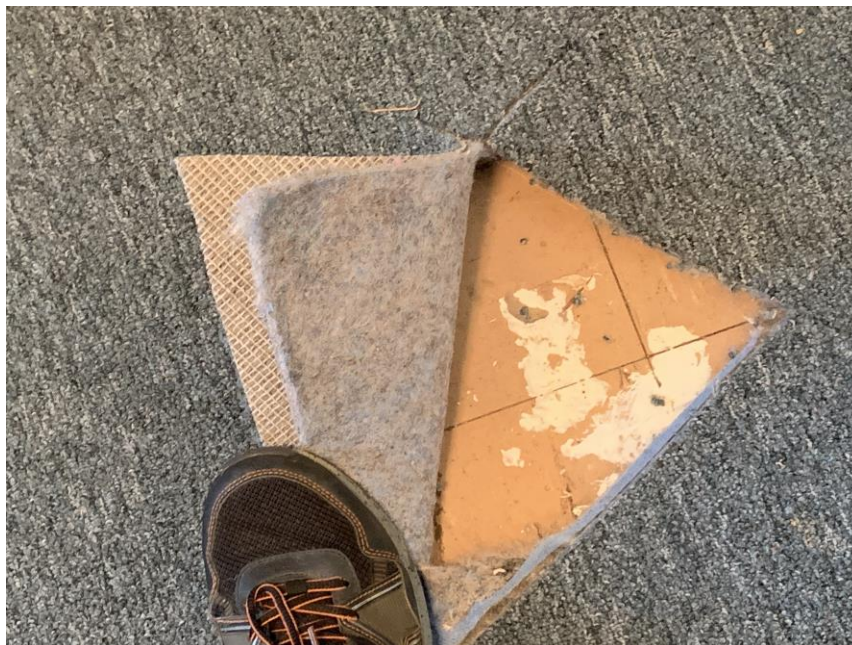
Homogeneous Material No. 7 – ACM 9" by 9" Tan Vinyl Floor Tile with Associated Black Mastic located under carpeting in Rooms 1 and 2 Adjoining the Sanctuary and on 2nd floor (original building construction).

JSK found asbestos containing materials during the survey. The identified RACM – Cat I Non-Friable ACM should be maintained in a good non-damaged condition until the building is demolished.

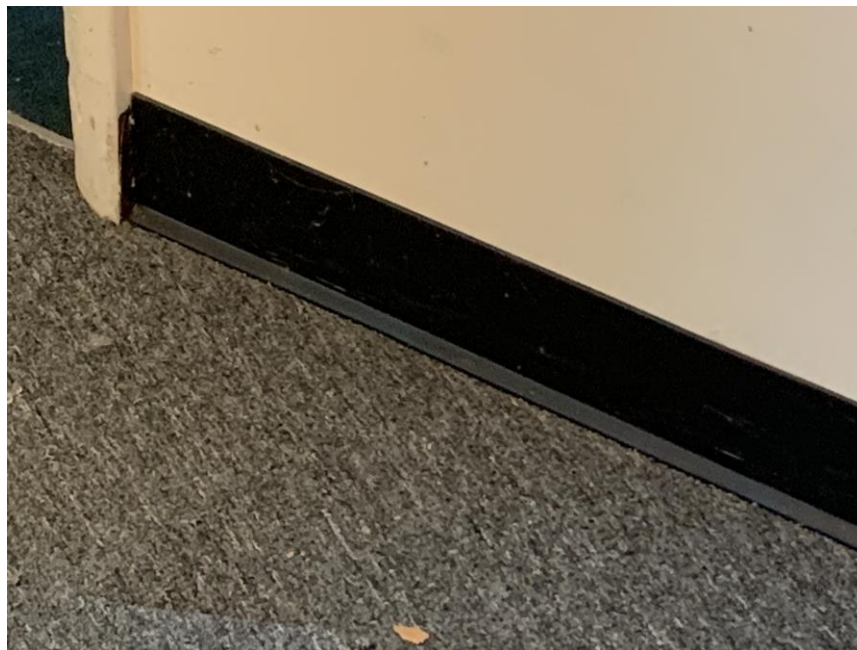
Homogeneous Material No. 8 – Non-ACM 4" Brown Vinyl Cove Base with associated tan mastic located in Rooms 1 and 2 adjoining the Sanctuary.

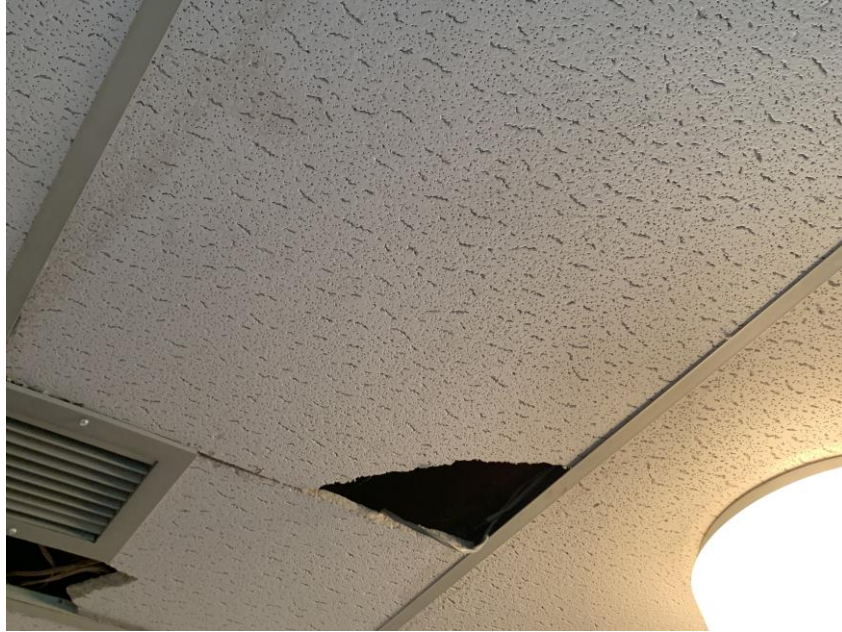
Homogeneous Material No. 9 – Non-ACM White 2' by 4' Lay-in Ceiling Tile with Fissures Design located in Rooms 1 and 2 adjoining Sanctuary.

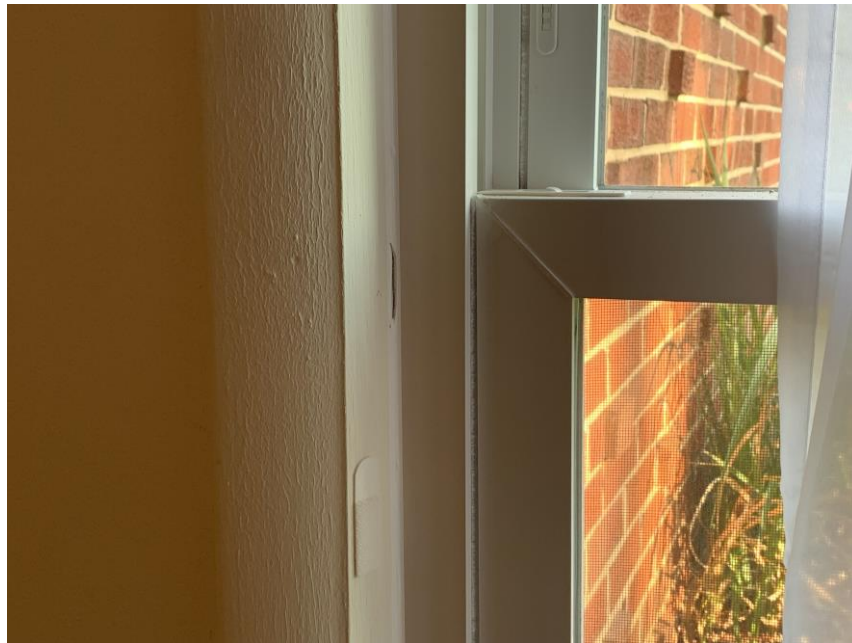
Homogeneous Material No. 10 – Non-ACM White Interior Window caulk located in Rooms 1 and 2 adjoining Sanctuary.

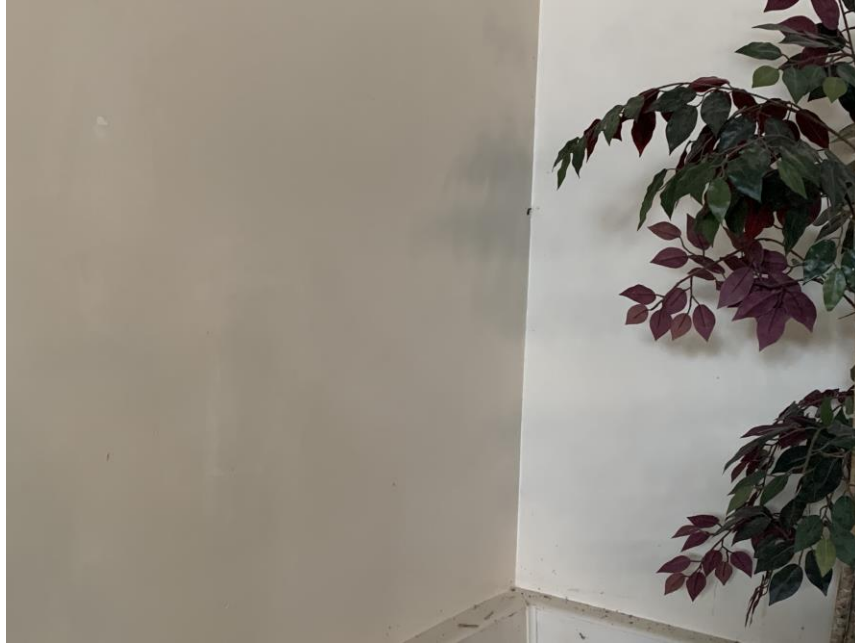
Homogeneous Material No. 11 – Non-ACM White Drywall with Associated White Joint Compound and White Paint located Throughout Sanctuary and Adjoining Rooms.

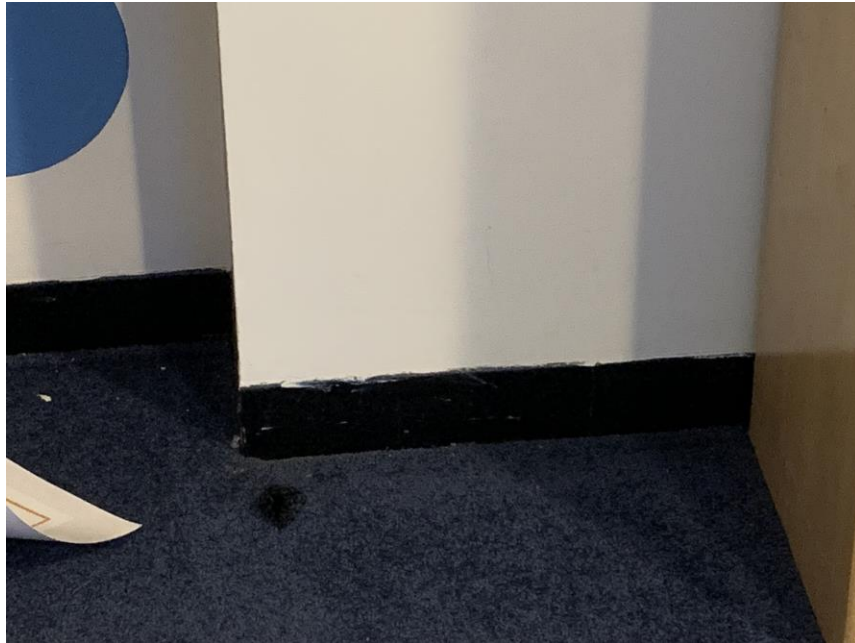
Homogeneous Material No. 12 – Non-ACM 4" Black Vinyl Cove Base with associated tan mastic located in Room 3 adjoining Sanctuary on the upper level.

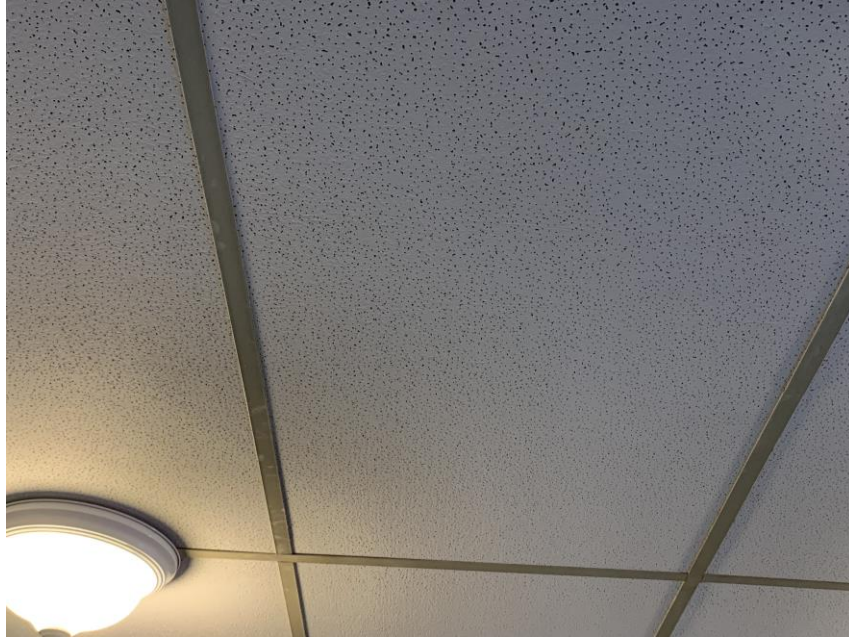
Homogeneous Material No. 13 – Non-ACM White 2' by 4' Lay-in Ceiling Tile with Pin Dots Design located in Room 3 adjoining Sanctuary on the upper level.

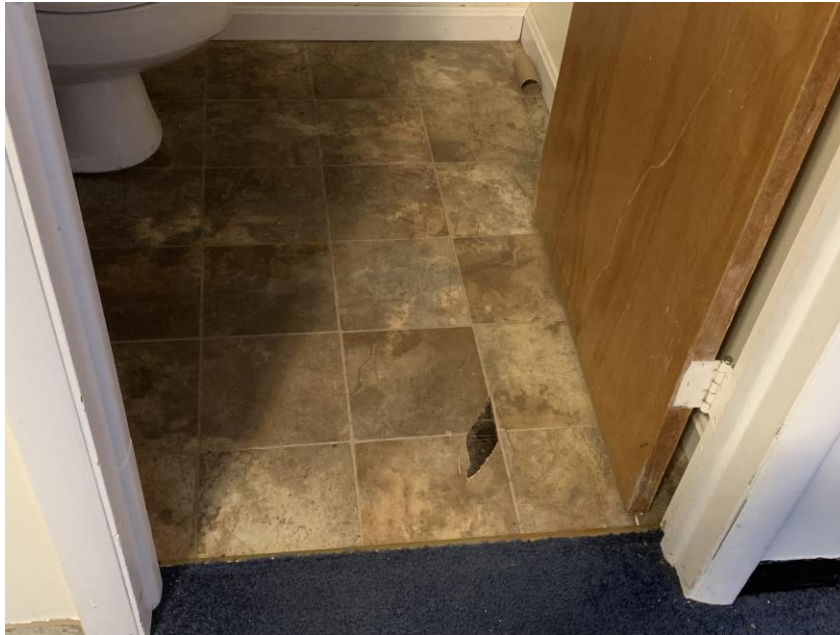
Homogeneous Material No. 14 – Non-ACM Brown square pattern Resilient Sheet Flooring located in Restroom adjacent to the sanctuary and the rear Foyer of the building.

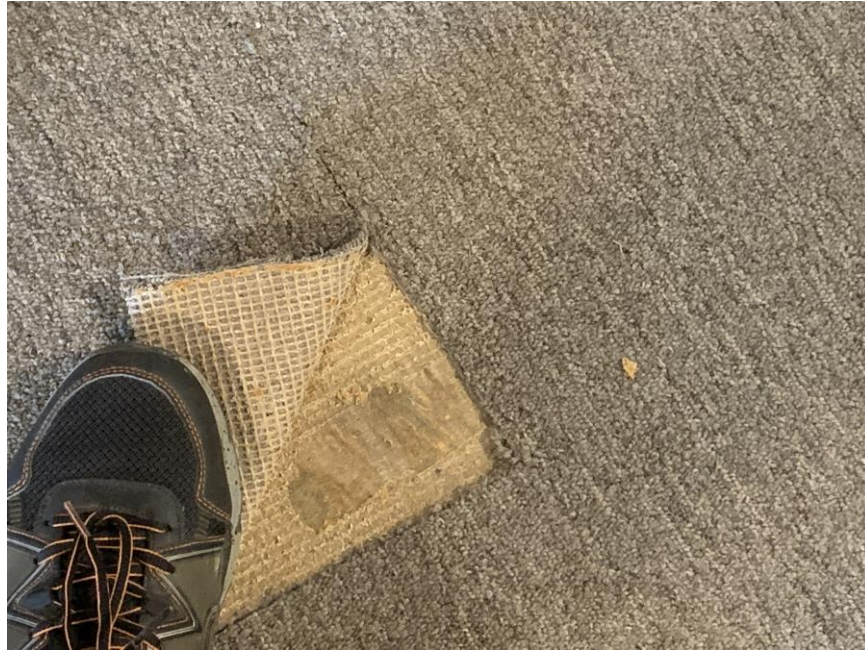
Homogeneous Material No. 15 – Non-ACM Tan Carpet Glue located in the rear Foyer of the building.

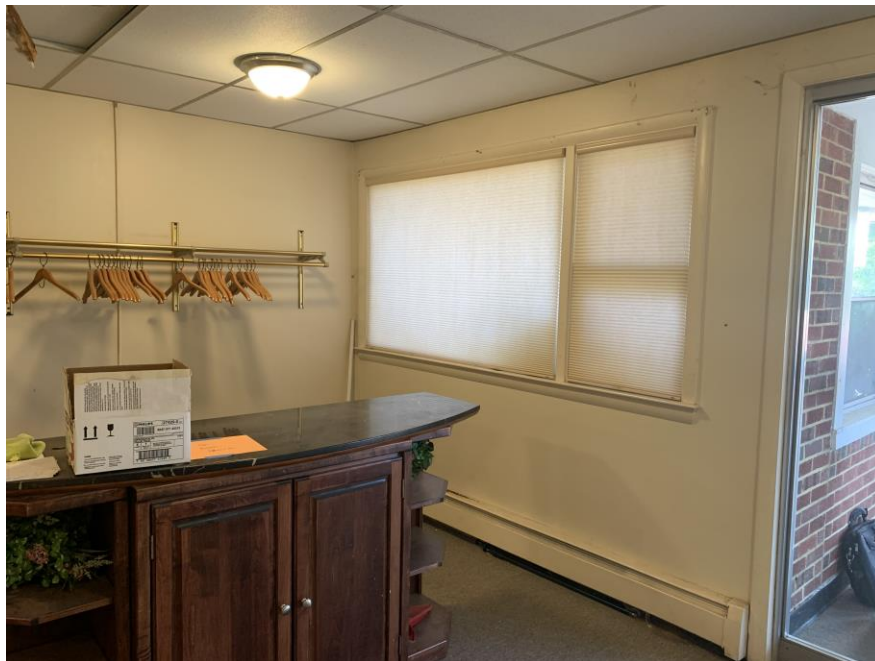
Homogeneous Material No. 16 – ACM White Drywall with Associated White Joint Compound, White Tape and White Paint located in the Girls' and Boys' restroom near Rear Foyer area of the building and throughout the original building construction on 1st and 2nd floor.

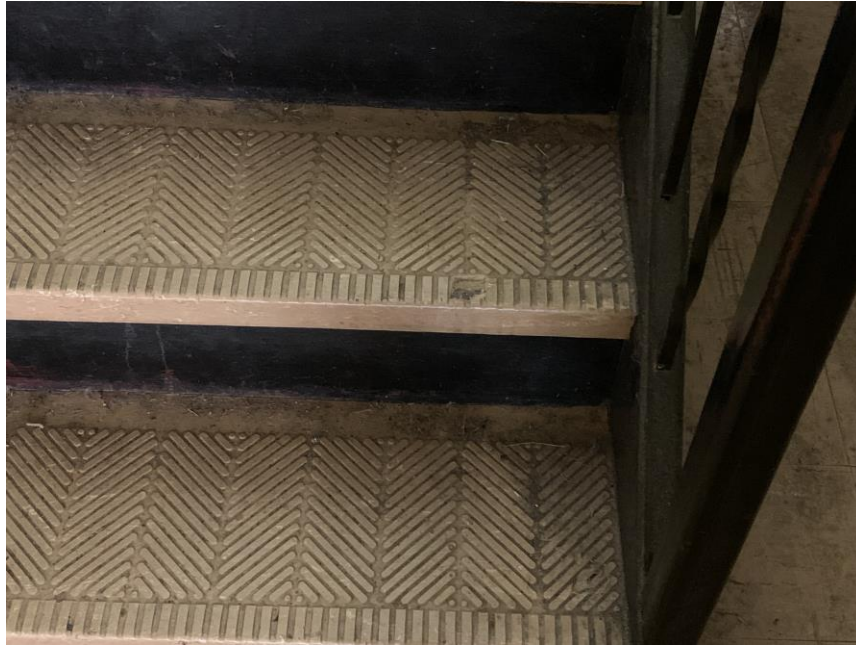
Homogeneous Material No. 17 – Non-ACM Tan Vinyl Stair Tread with associated Tan Mastic located in Stairwell leading to 2nd floor near rear foyer area (original building construction).

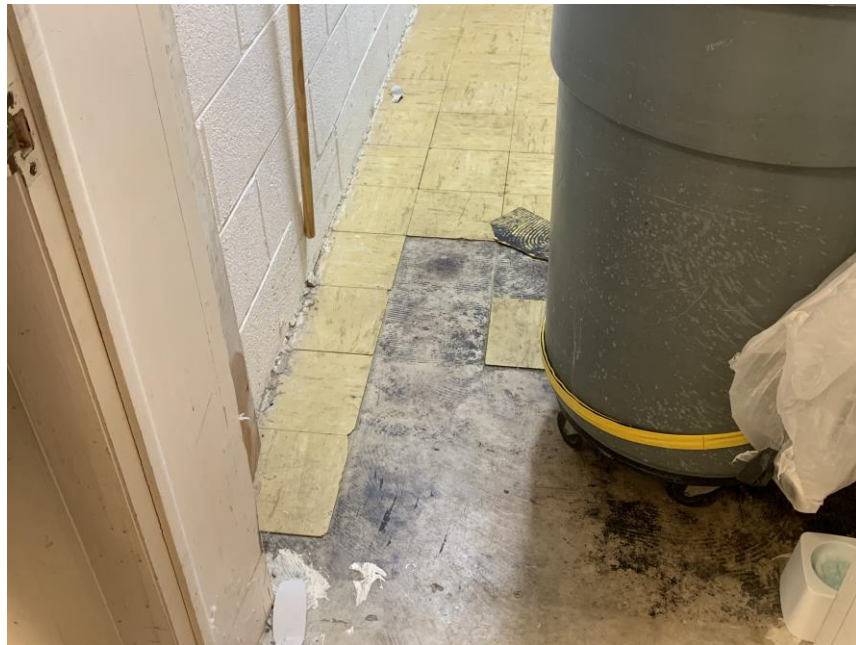
Homogeneous Material No. 18 – ACM Cream 9" by 9" Vinyl floor Tile with associated black mastic located in the 1st floor storage room across from the rear foyer area.

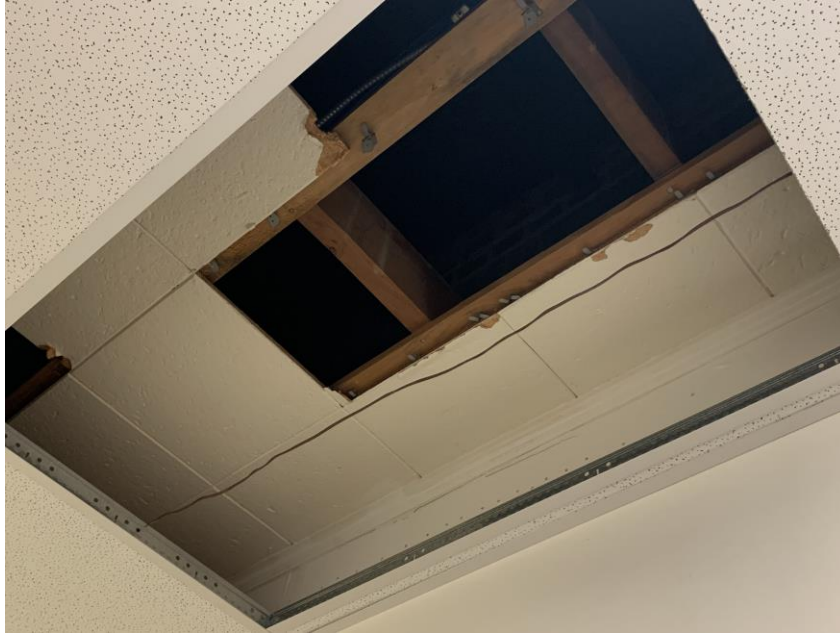
Homogeneous Material No. 19 – Non-ACM White 1' by 1' Lay-in- Ceiling Tile located throughout 1st floor corridor near the rear foyer area (original building construction).

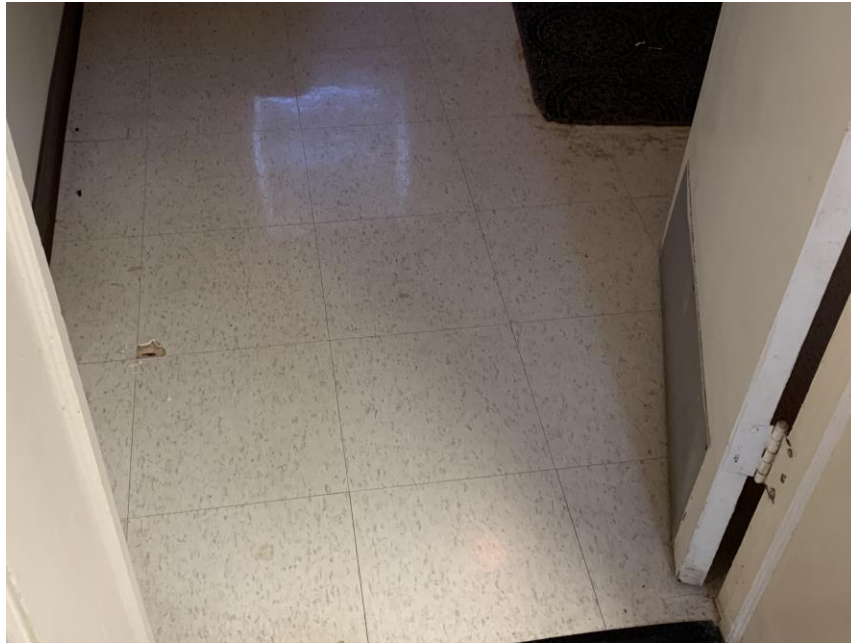
Homogeneous Material No. 20 – Non-ACM Cream mottled 12" by 12" Vinyl Floor Tile with associated cream mastic located in Girl's restroom near the rear foyer area (original building construction).

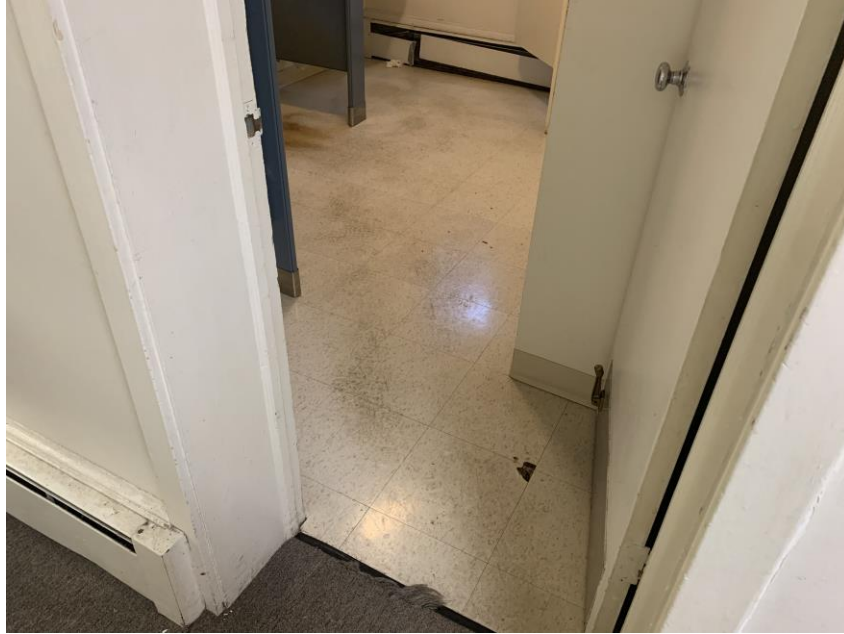
Homogeneous Material No. 21 – Non-ACM Cream mottled 12” by 12” Vinyl Floor Tile with associated Black mastic located in Boy’s restroom near the rear foyer area (original building construction).

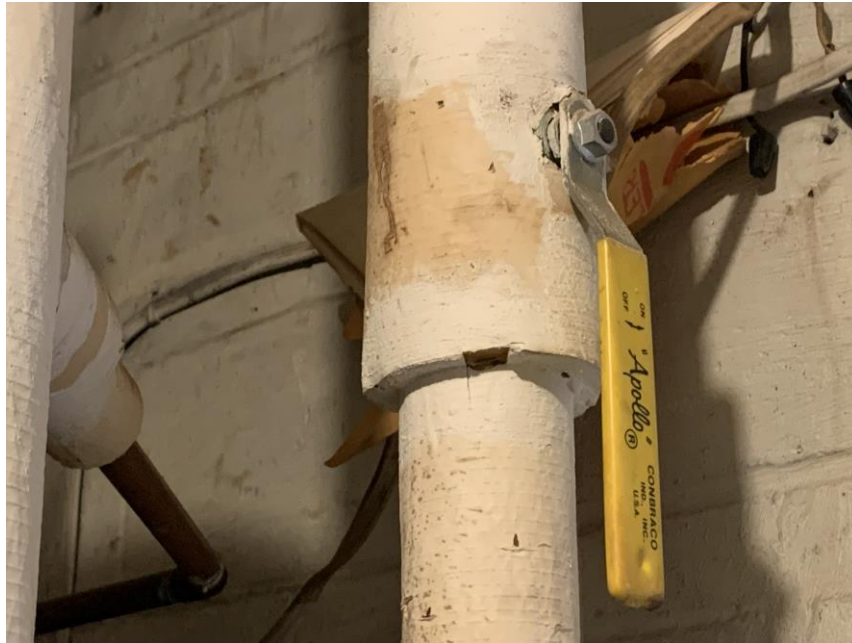
Homogeneous Material No. 22 – Non-ACM White Pipe insulation Mastic located in the Mechanical Room.

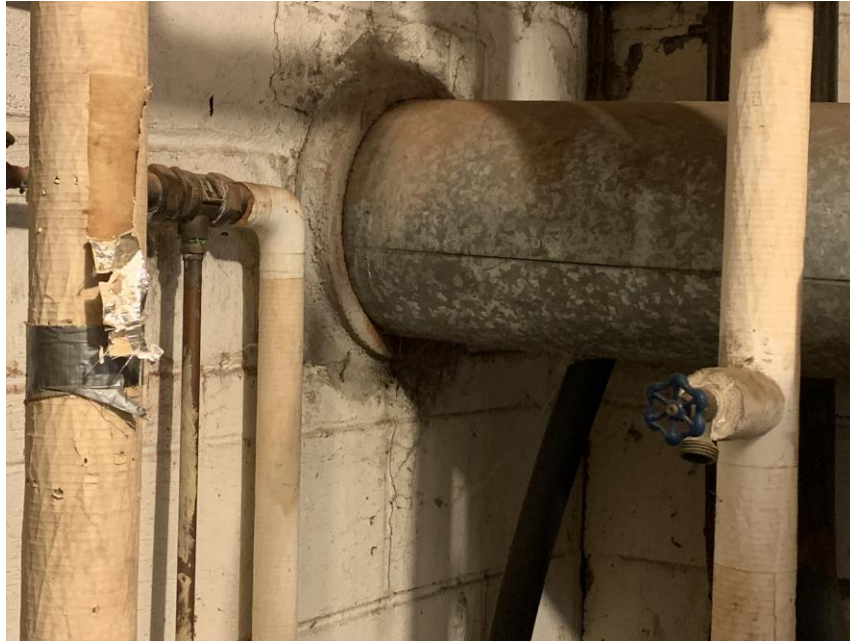
Homogeneous Material No. 23 – Non-ACM Gray Boiler Flue Pipe Wall Packing located in the Mechanical Room.

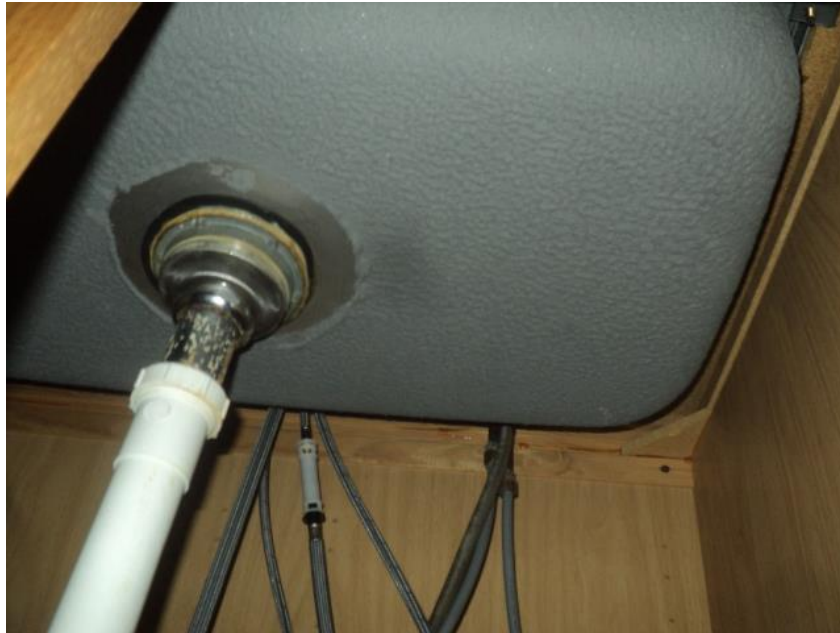
Homogeneous Material No. 24 – Non-ACM Gray Sink Bowl Mastic Coating located in the Kitchen area adjacent to multi-Purpose Room.

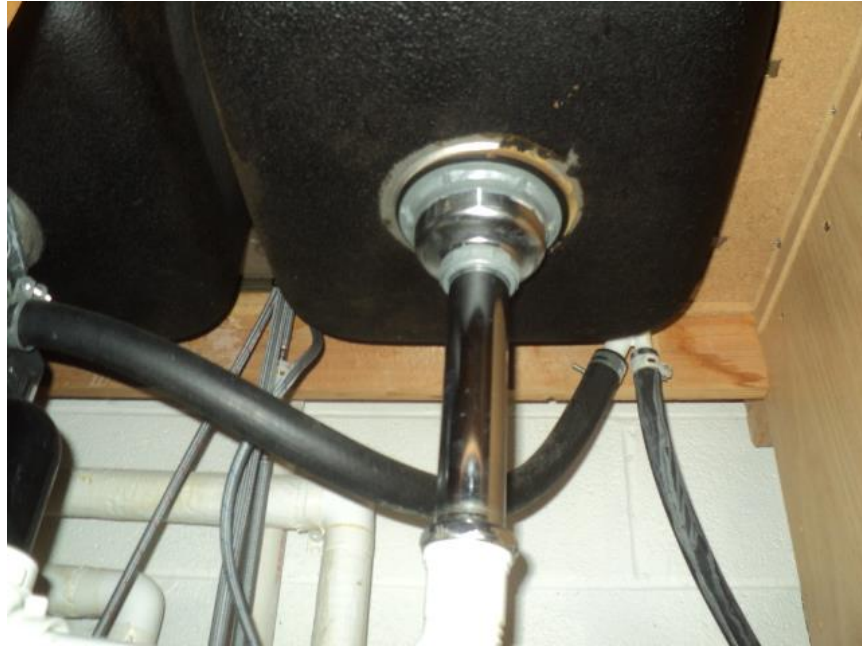
Homogeneous Material No. 25 – ACM Black Sink Bowl Mastic Coating located in the Kitchen area adjacent to multi-Purpose Room.

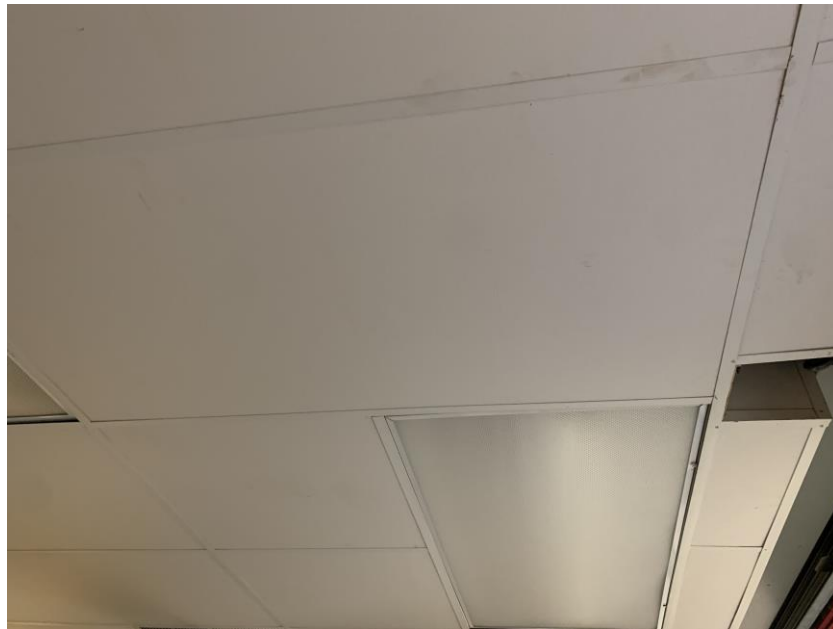
Homogeneous Material No. 26 – Non-ACM White Gypsum 2' by 4' Ceiling Tile located in the Kitchen area adjacent to multi-Purpose Room.

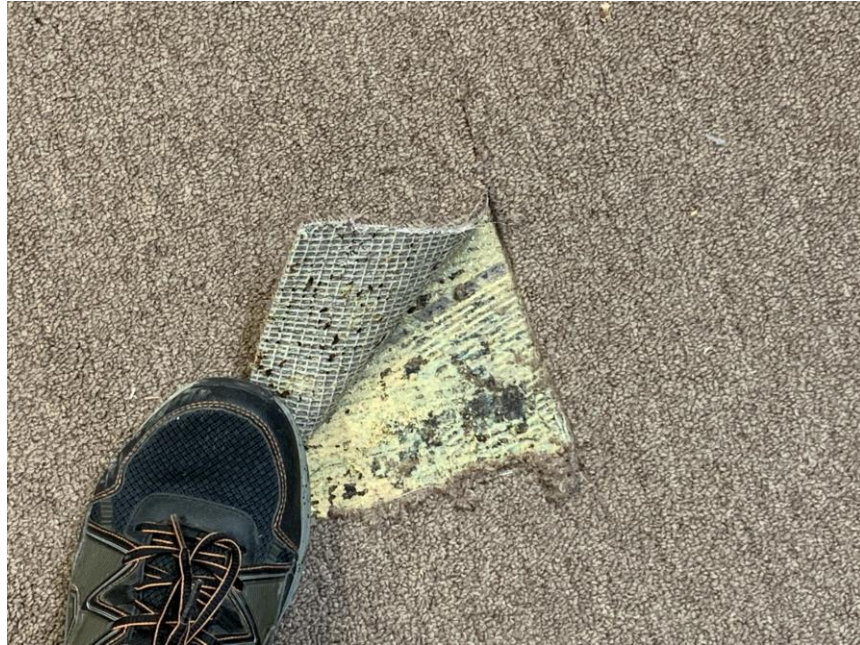
Homogeneous Material No. 27 – Non-ACM Yellow Carpet Glue mixed in with Black Mastic located in Classroom 2 adjacent to multi-purpose Room.

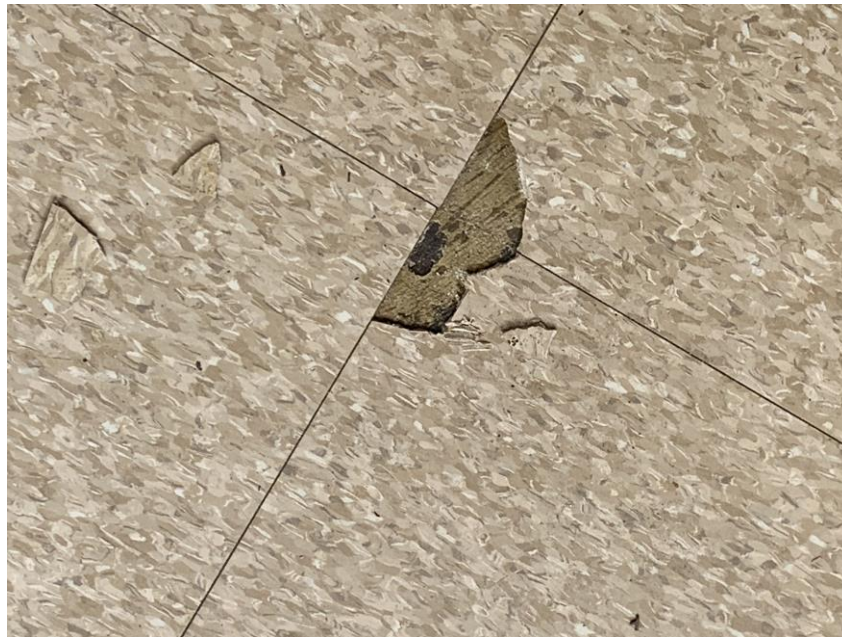
Homogeneous Material No. 28 – Non-ACM Brown mottled 12" by 12" Vinyl Floor Tile with associated tan/black Mastic located in 2nd Floor Classroom 1 (original building construction).

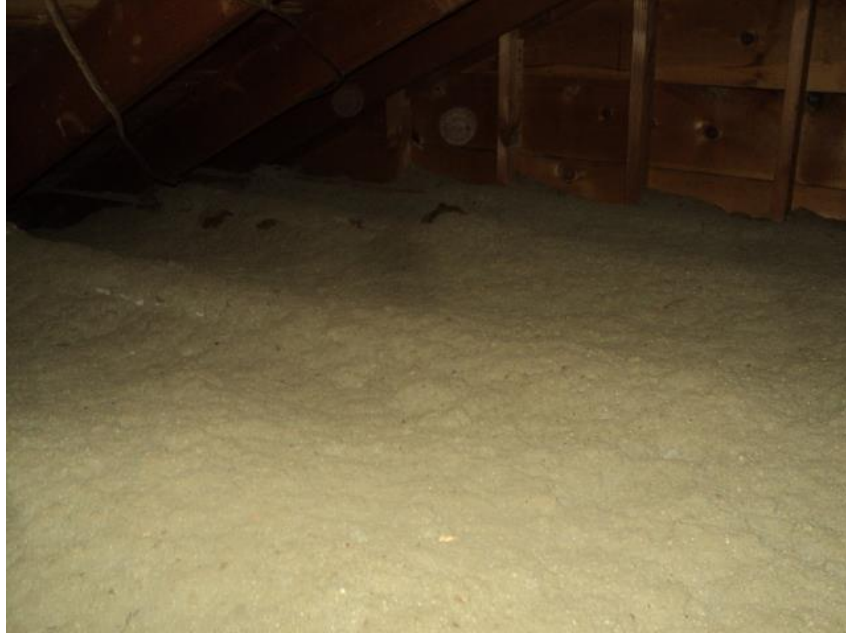
Homogeneous Material No. 29 – Non-ACM Tan Blown-in Attic Insulation located in the Attic on the 2nd floor (original building construction)..

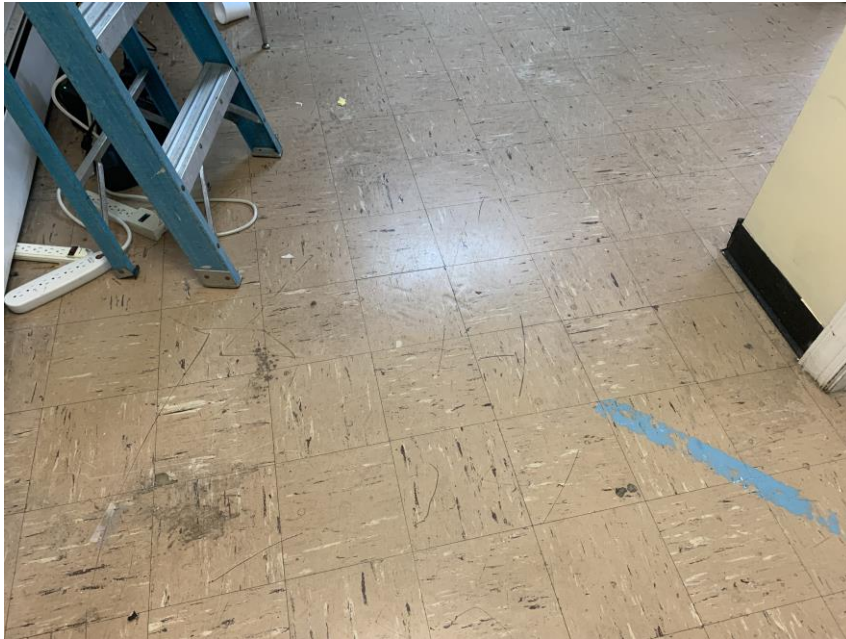
Homogeneous Material No. 30 – ACM Tan with brown streaks 9" by 9" Vinyl Floor Tile with associated black mastic located in the 2nd Floor Corridor, classrooms and throughout the original building construction.

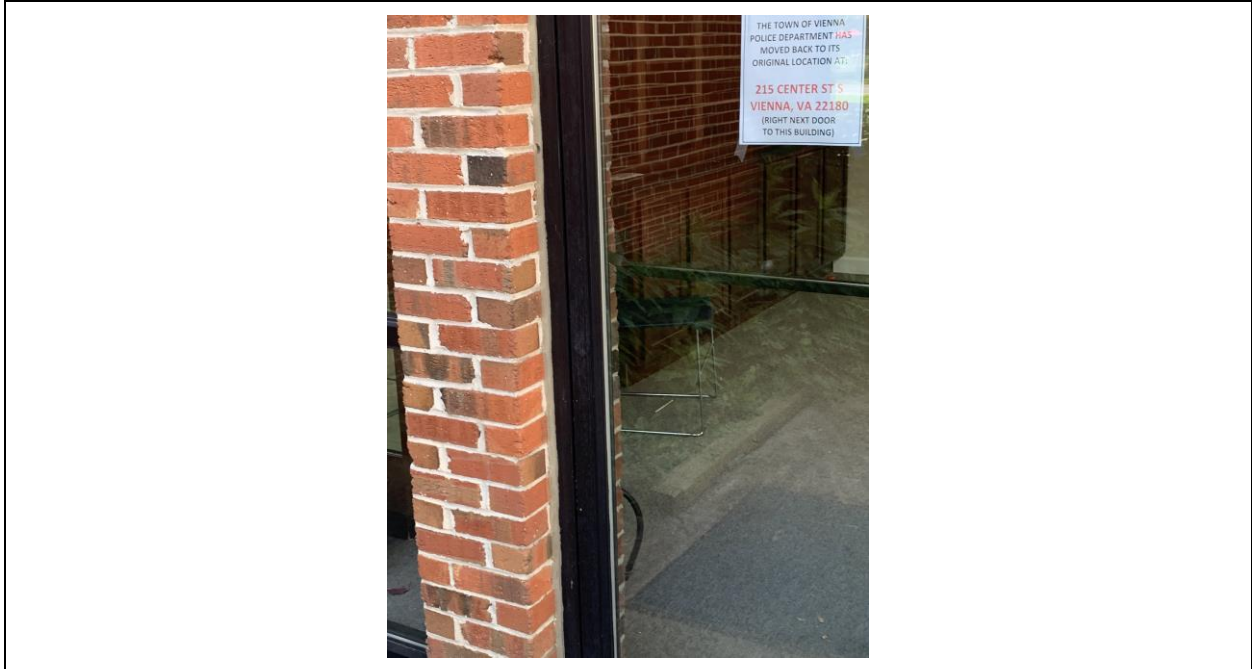
Homogeneous Material No. 31 – Non-ACM Brown exterior door caulk located on the front entrance door.

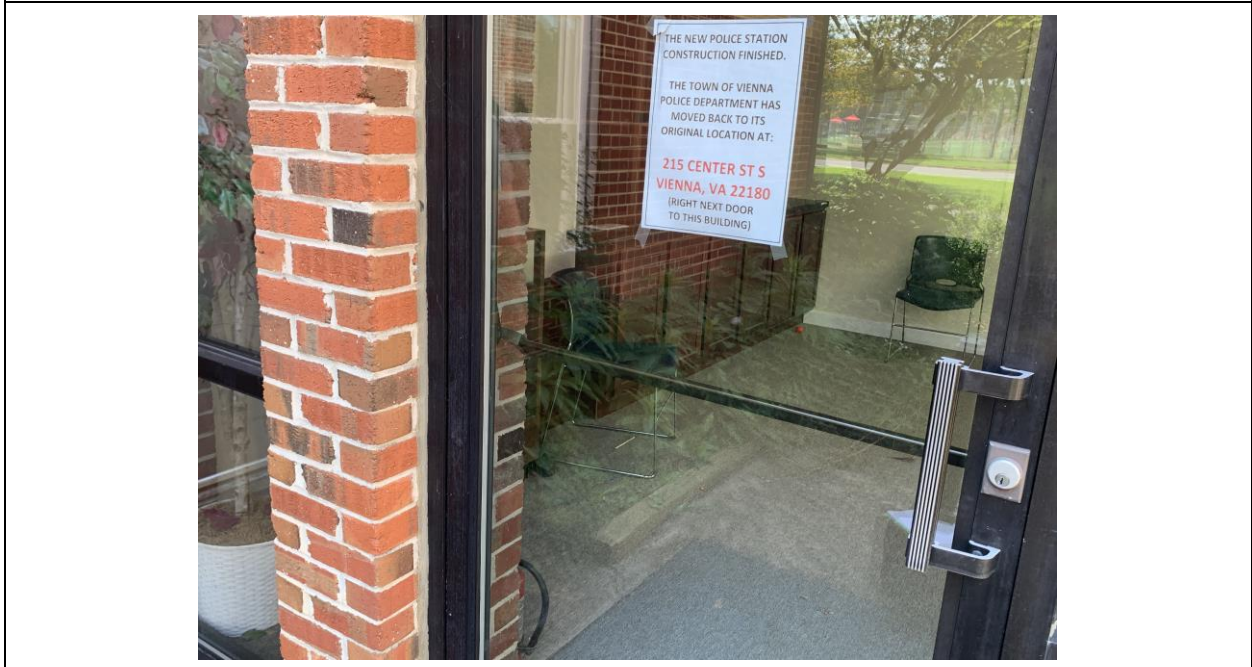
Homogeneous Material No. 32 – ACM White exterior door caulk located on the front entrance door and exterior door on left side of building.

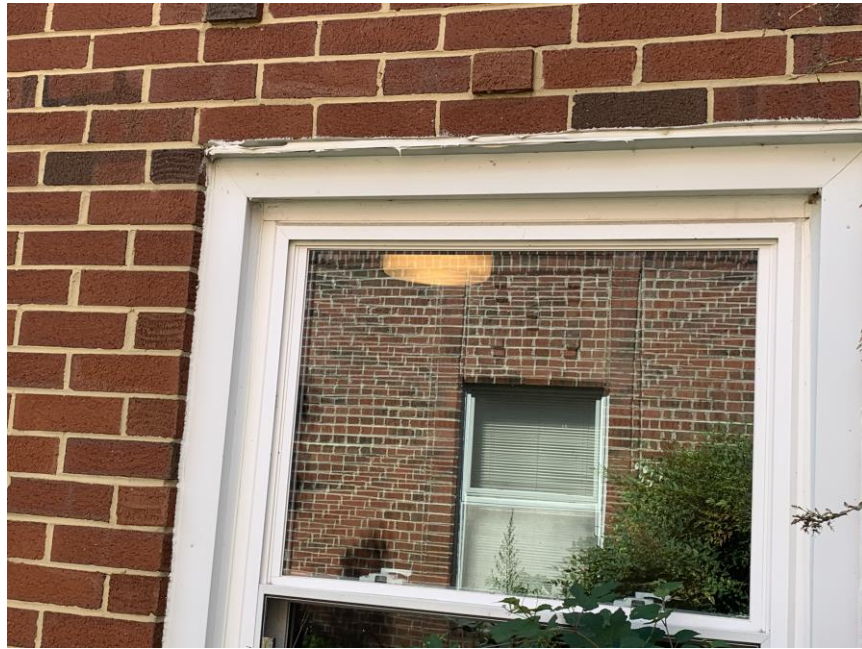
Homogeneous Material No. 33 – Non-ACM White exterior window caulk located on the Left and right-side exterior windows.
