BOUTON'S HALL CONDITIONS ASSESSMENT
FOR THE TOWN OF VIENNA

GAUTHIER
ALVARADO
ASSOCIATES

06.28.2018

Bouton's Hall Conditions Assessment

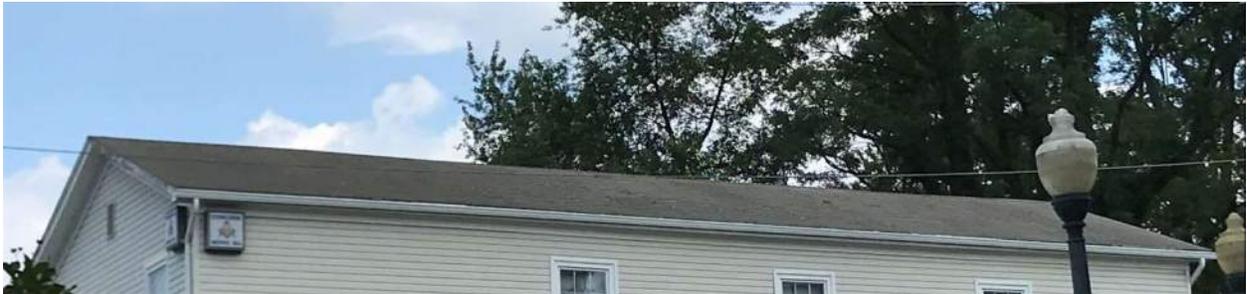
shingles appear to be separating from the roof assembly. The rafters are also telegraphing through the roof assembly, which suggests the roof sheathing may need to be replaced in addition to the asphalt shingle roofing. If the current roof assembly is thirty years old as suggested by the current owner, it has surpassed its anticipated life span.

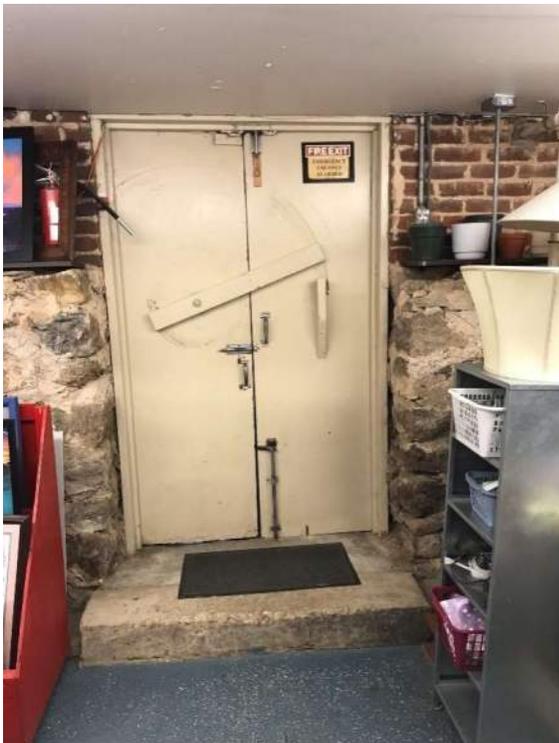
The double door exit in the basement does not currently meet code due to several deficiencies, including the door hardware, minimum door height and minimum door width of one of the door leaves. However, with an existing ceiling height of 6'-11", the basement does not meet the current minimum ceiling height for occupiable space. We believe the space could meet the minimum ceiling height if the ceiling finish were removed.

The slope of the ramp on the exterior of the double door needs to be evaluated during a feasibility study, as the ramp appears to exceed the maximum allowable slope for a means of egress. This ramp would require handrails on both sides.

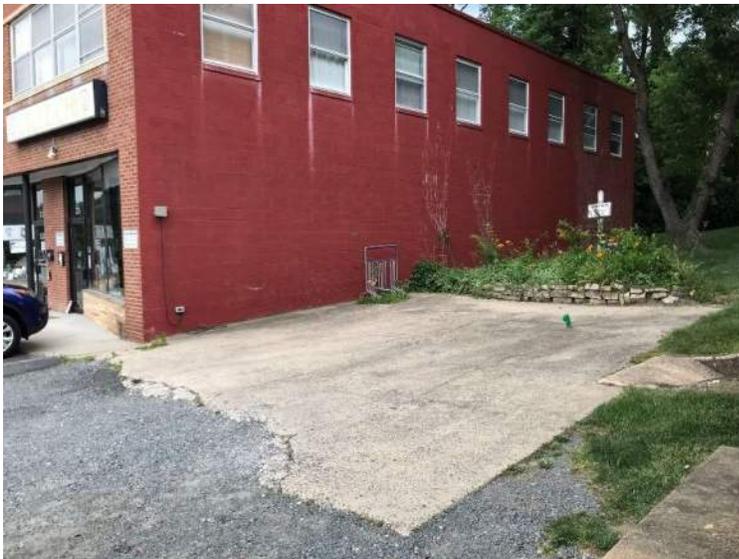
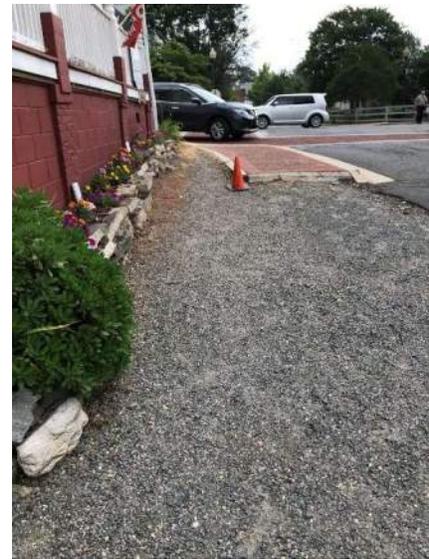
When approaching the building from an accessible parking space, an accessible slope at grade must be continuously maintained along a route to a building entry. There are currently no accessible routes to any of the existing building entries. As indicated in the images below, there is an abrupt edge at the existing concrete parking pad and at the edge of the existing brick sidewalk. There should be a continuous firm surface which is slip-resistant and where there are no gaps or holes along the accessible route to the building entry.

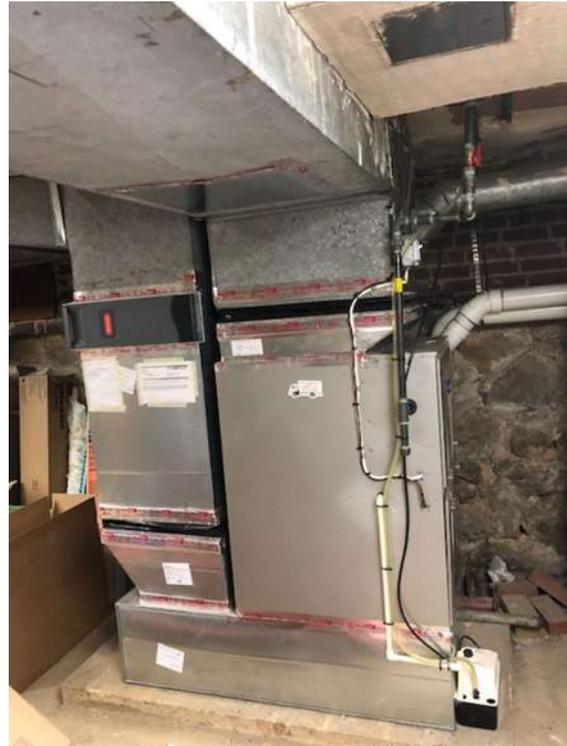
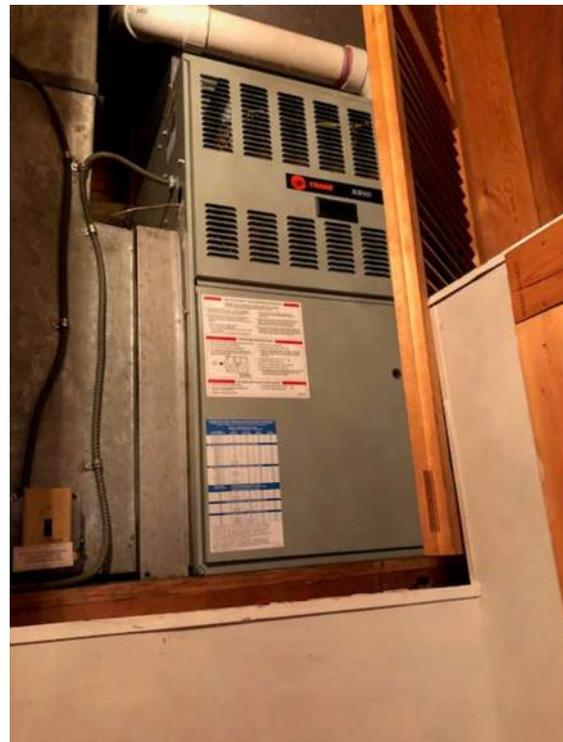
The furnace serving the Masonic Meeting Space is located on the upper floor in an elevated closet. Access to this unit for servicing is cumbersome. The furnace serving retail space is located in the basement and access is adequate.

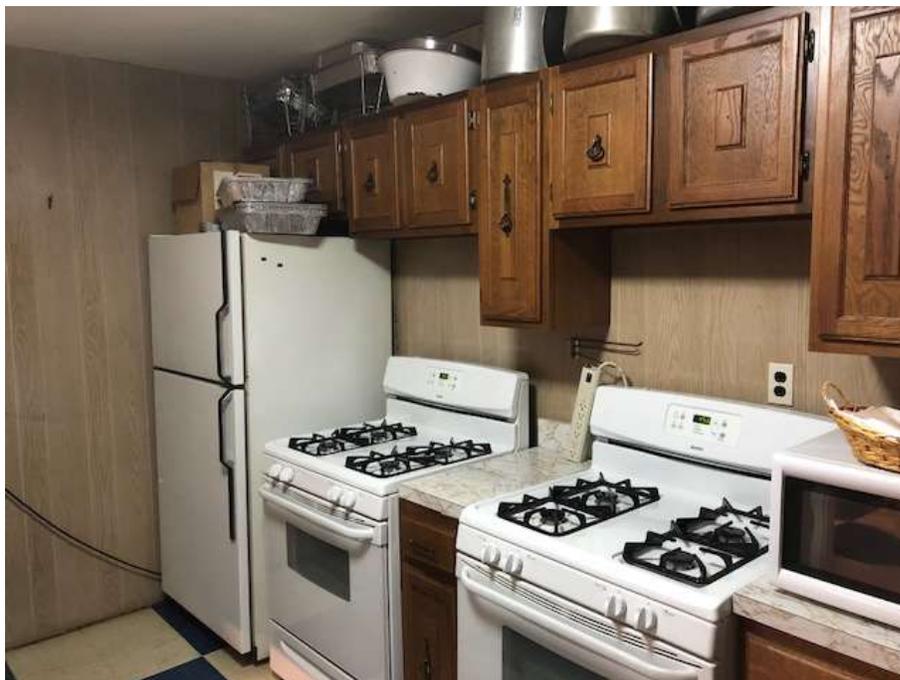
The Masonic Meeting Space includes a kitchen with two combination gas range top and ovens. There is no exhaust provided for these appliances, which is also a code violation.

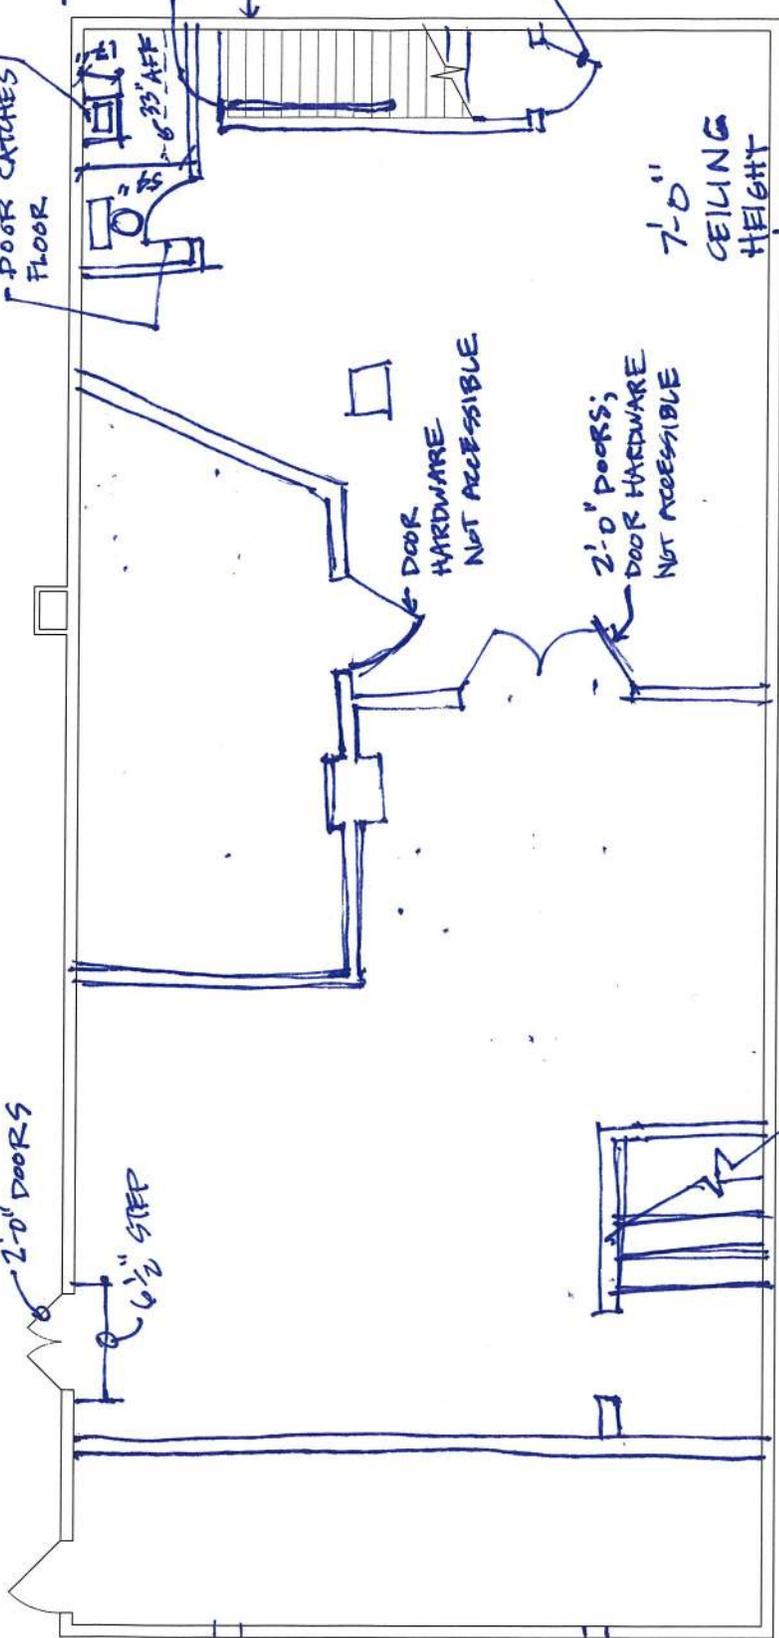
Project		BOUTON'S HALL CONDITIONS ASSESSMENT	
Title		BASEMENT FLOOR PLAN FIELD SURVEY	
Date	Scale	Project No.	Sketch No.
06.19.18	1/8" = 1'-0"	73301	SK-01

7'-0"
CEILING
HEIGHT

LOOK FOR STORAGE,
NOT OCCURABLE SPACE
PER VCC, ACCEPTABLE
PER VRC

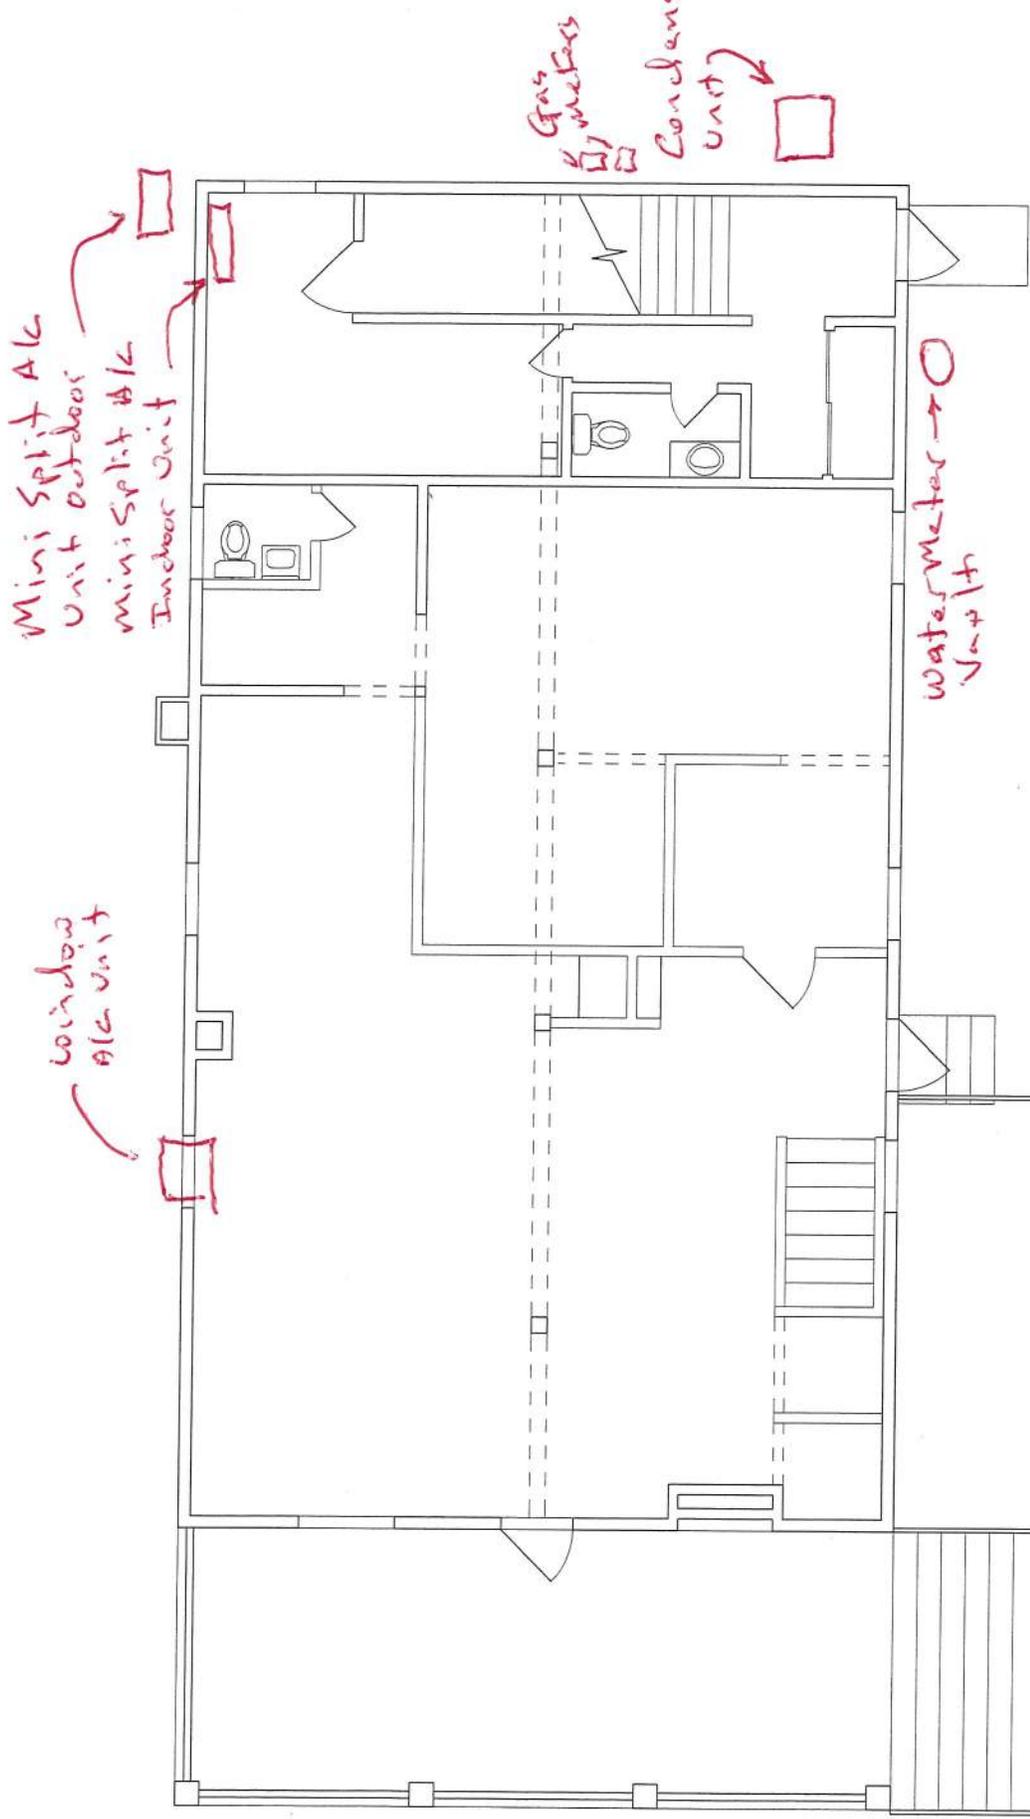
Project	BOUTON'S HALL CONDITIONS ASSESSMENT	
Title	BASEMENT FLOOR PLAN FIELD SURVEY	
Date	6/19/18	Scale 1/8" = 1'-0"
Project No.	13301	Sketch No. SK-01

Mechanical/Plumbing

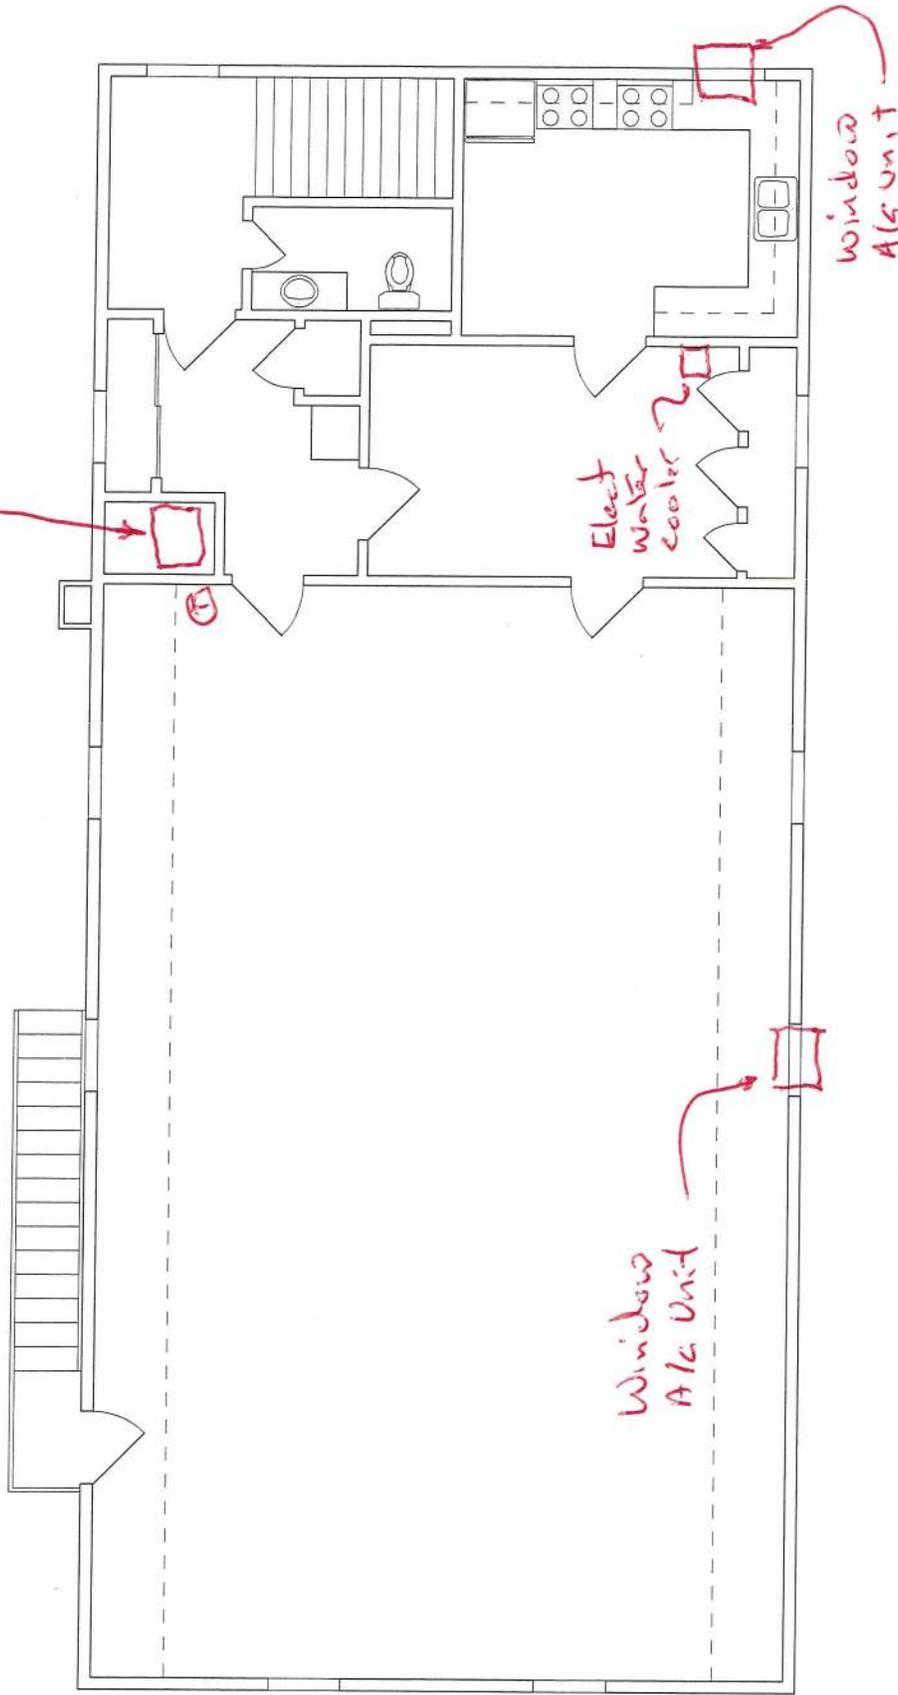
Sketch No. **SK-02**

Masonic Space
Furnace

Elect
Water
cooler

Window
A/C Unit

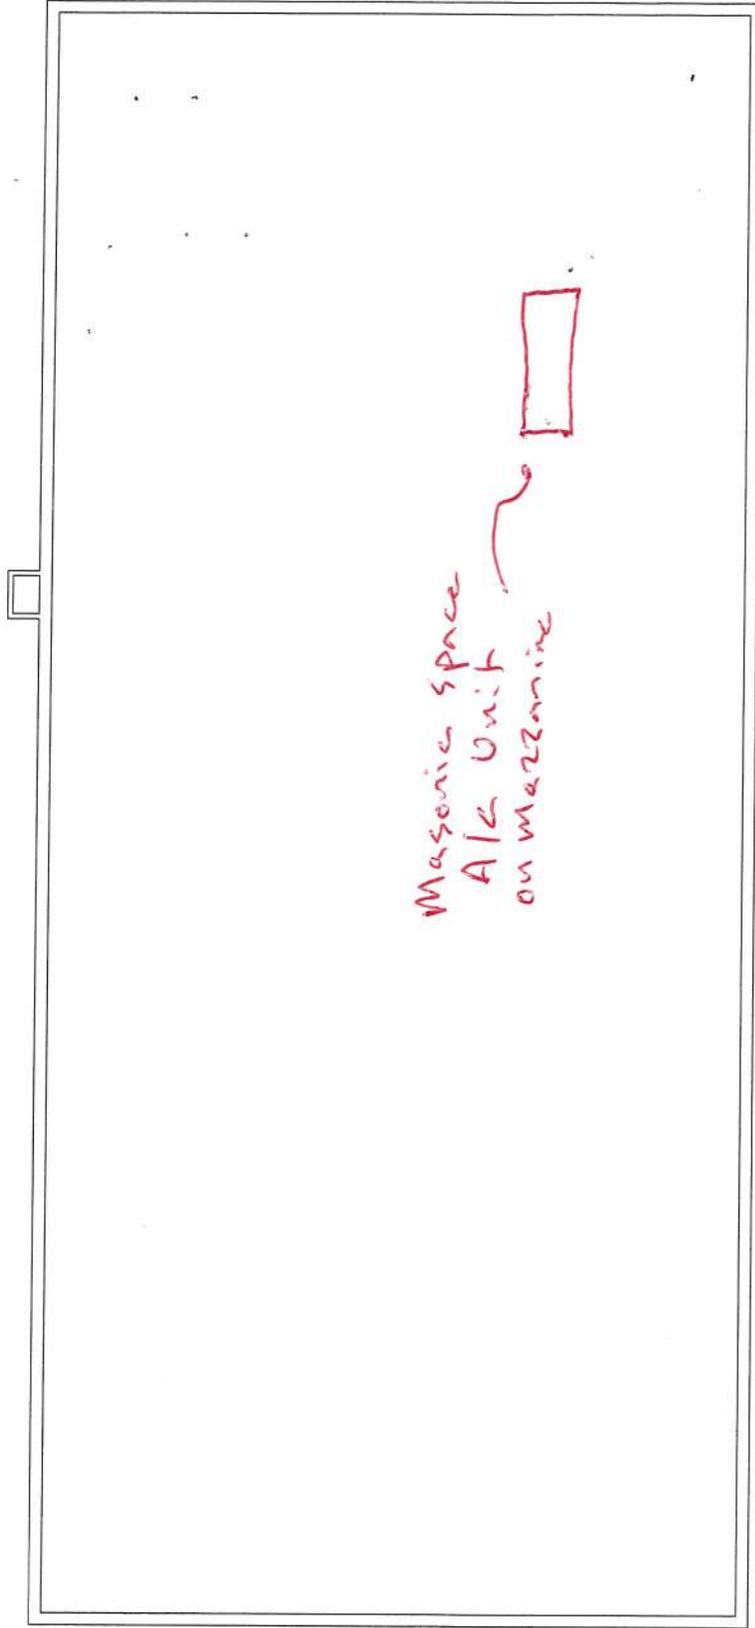
Date **6/19/18** Scale **1/8"=1'-0"**
Project No. **T3301** Sketch No. **SK-03**

Mechanical / Plumbing
