# ELMAR ST SE/SW ENGINEERING REPORT

## ROBINSON TRUST SIDEWALK PROGRAM

July 28, 2022

**CONCEPT 2-  
SIDEWALK WITH UTILITY STRIP ALONG SOUTH SIDE  
AND REBUILD STREET TO 32' FC TO FC**

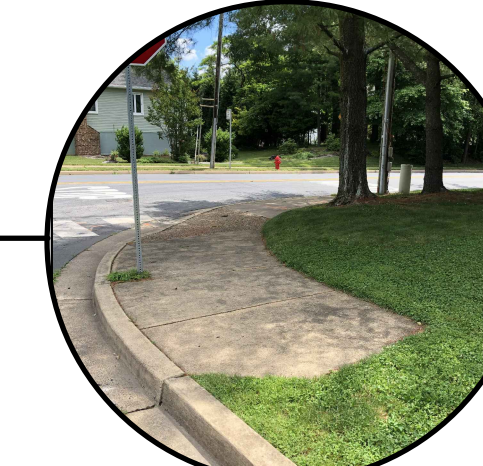
The new sidewalk will connect to existing sidewalk at Park Street. The curb return radii will be reduced to 25' and a current standard ADA ramp will be provided.

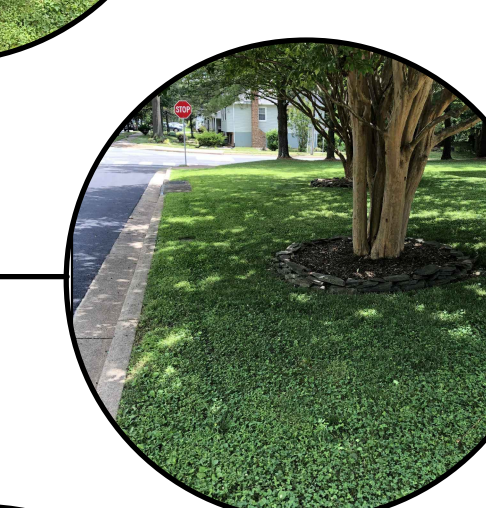
The sidewalk against the curb will be maintained across the frontage of #117 to preserve the existing trees (2- 30" Crepe Myrtles).

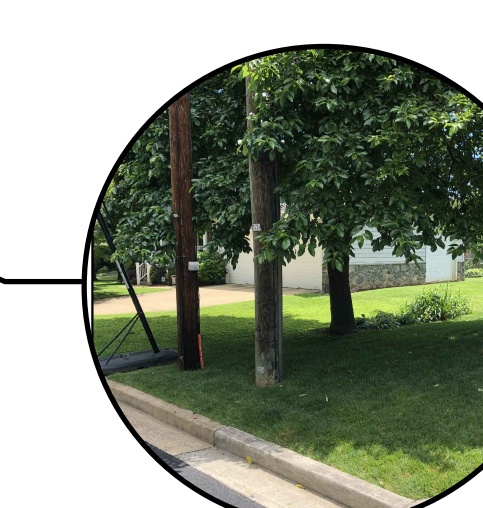
At the location of the 2 utility pole between #115 and #117 the sidewalk would be built adjacent to existing curb without utility strip. The 20" Black Gum Tree will be preserved.

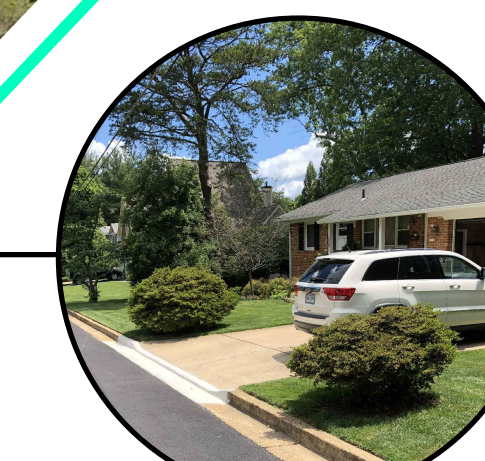
At #113 the shrubs on either side of the driveway and the 10" Flowering Dogwood are in the R/W and will need to be removed for the new sidewalk.

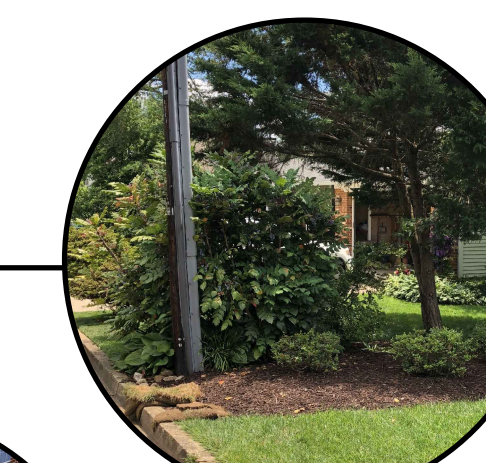
At the location of the utility pole between #111 and #113 the sidewalk would be built adjacent to existing curb without utility strip.

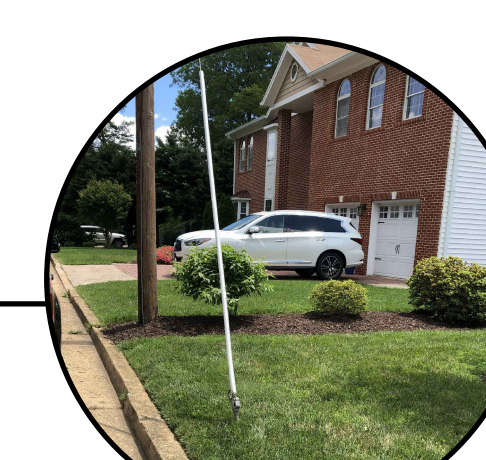
At the location of the utility pole and guy anchor along the frontage of #109 the sidewalk would be built adjacent to existing curb without utility strip.

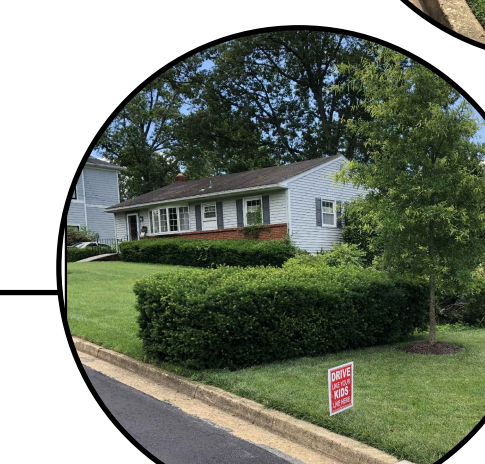
At #107 the shrubs in the TOV R/W will need to be removed to construct the new sidewalk.

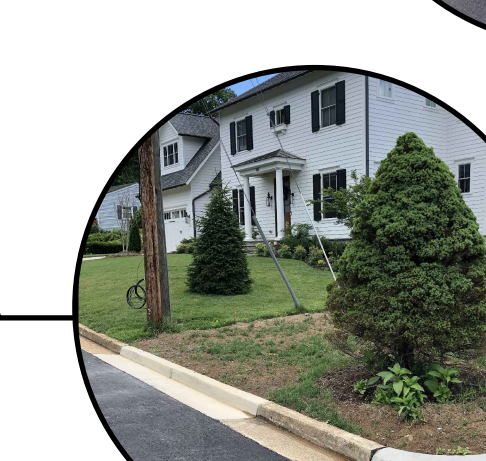
At the location of the utility pole between #103 and #105 the sidewalk would be built adjacent to existing curb without utility strip.

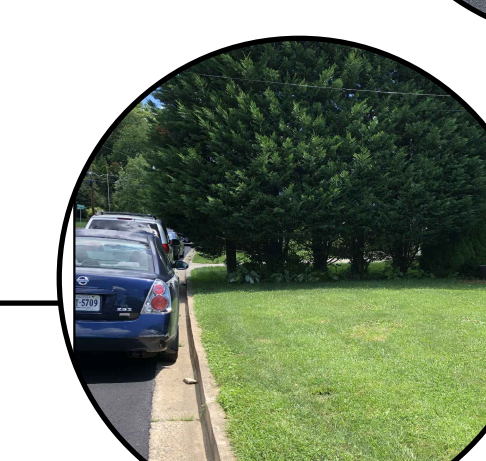
The new sidewalk will end at the Desale intersection with a new ADA ramp and smaller curb return radii of 25' provided.

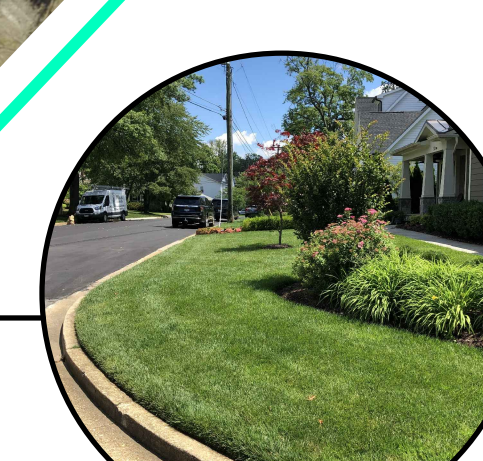
At the location of the utility pole between #102 and #100 the sidewalk would be built adjacent to existing curb without utility strip. The branches of the Leyland Cypress will need to be trimmed or the tree, or the tree can be removed.

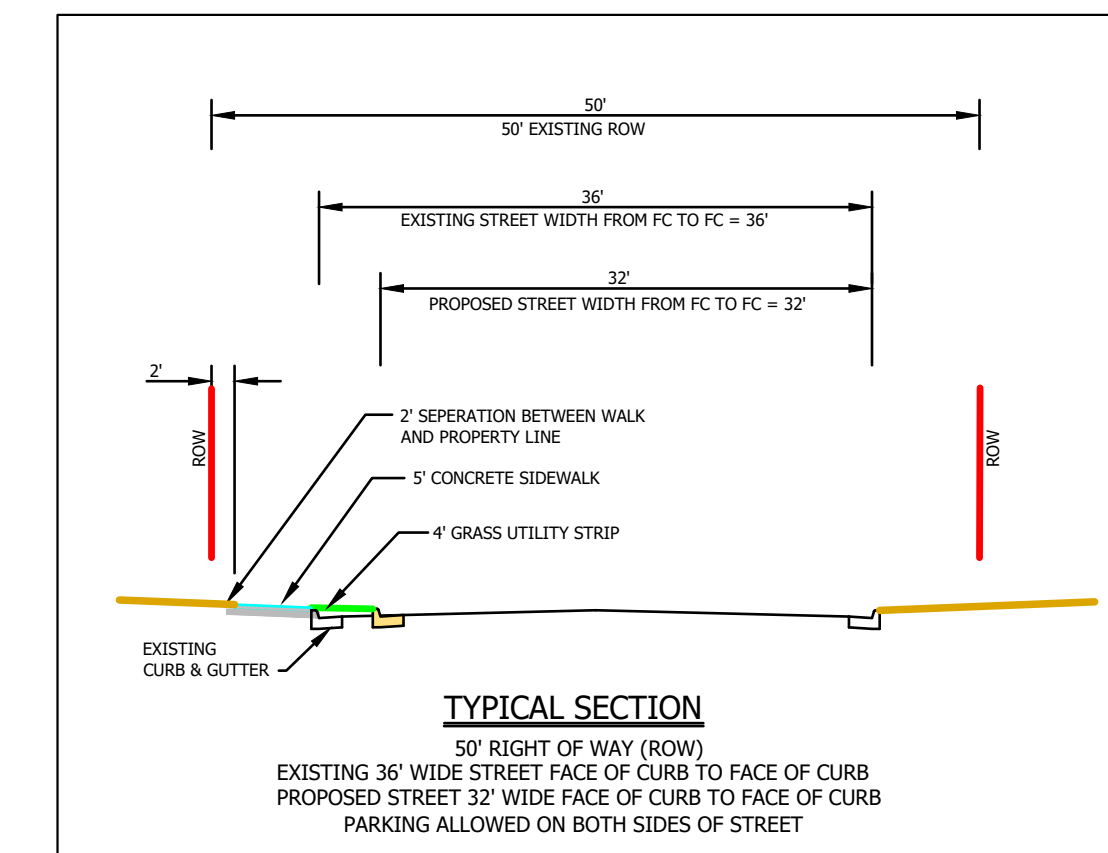
**CONCEPT 2- PROJECT DESCRIPTION**  
Sidewalk along the south side of Elmar Drive from Desale St SW to Park St SE. There is currently no sidewalk on either side of Desale; however, a sidewalk project is under consideration. This project will connect to the Desale project directly or by a crosswalk depending on which side of Desale is selected for the project. The street width will be reduced from 36' to 32' for the length of the project. This will allow the new sidewalk to route in front of the utility poles. The curb return radii at the Desale intersection and at the Park Street intersection will be reduced. The narrower street width and reduced curb return radii will provide traffic calming to the street and reduce project impacts on existing properties and trees as there will be a 2' separation from the back of walk to the R/W. The sidewalk will connect to existing sidewalk at Park Street SE. New standard ADA ramps will be provided.
