Exterior Lighting Compliance

Chip Imrie, GMR Protection Resources, Inc.

Date: January, 26, 2011

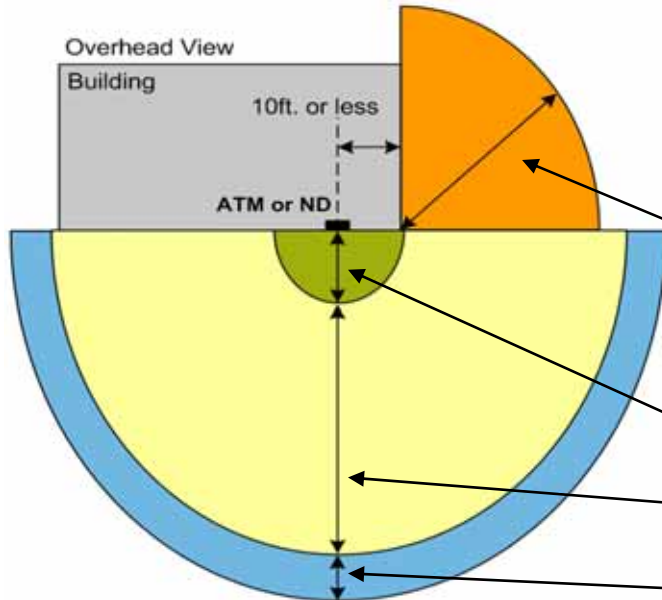
Through The Wall ATM or ND

- When an ATM or ND is within 10 feet of the building corner the following requirement applies: Adjacent corner to 40 feet = Minimum of 2 foot-candles
- 0 to 5 feet = Minimum of 10 foot-candles
- 5 to 50 feet = Minimum of 2 foot-candles
- Nearest designated parking within 60 feet = Minimum of 2 foot-candles

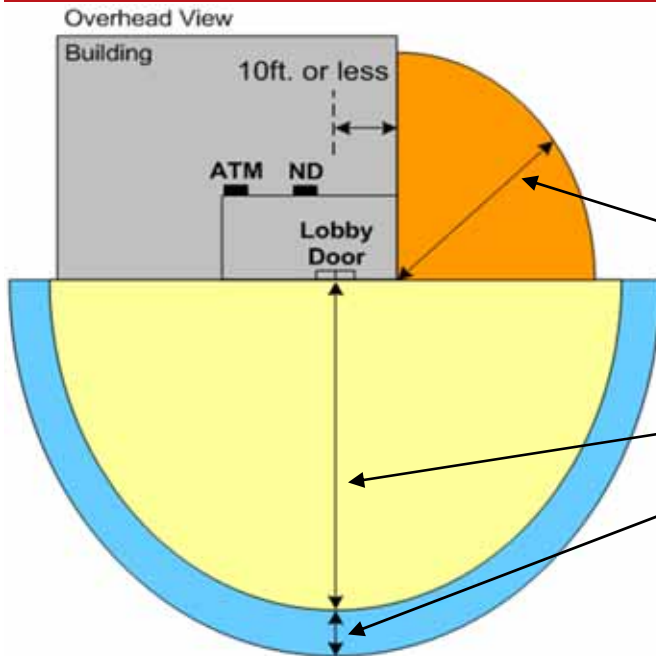
Lobby ATM's and ND's (Part 1 of 3)

From the entrance door outward

- When the lobby door is within 10 feet of the building corner the following requirement applies: Adjacent corner to 40 feet = Minimum of 2 foot-candles
- 0 to 50 feet = Minimum of 2 foot-candles
- Nearest designated parking within 60 feet = Minimum of 2 foot-candles

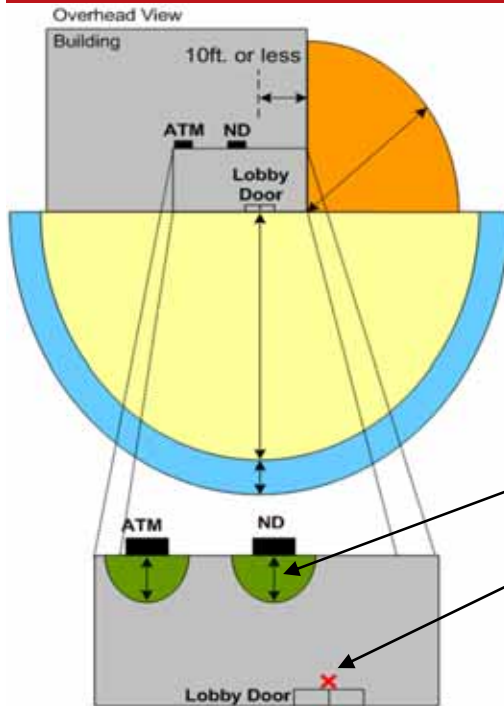
Lobby ATM's and ND's (Part 2 of 3)

Inside the lobby

- 0 to 5 feet = Minimum of 10 foot-candles
- Minimum of 2 foot-candles inside each lobby entry

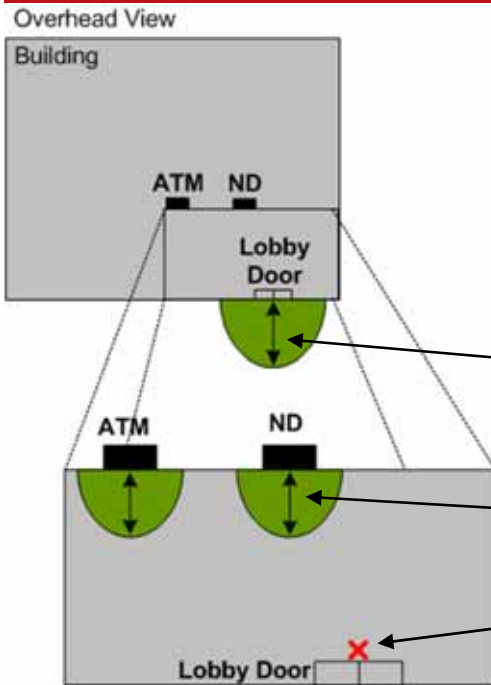
Lobby ATM's and ND's (Part 3 of 3)

Vestibules located on the street where the only way to access the lobby is by using the public sidewalk and there is no bank controlled parking within 60 feet of the entrance.

From the entrance door outward

- 0 to 5 feet = Minimum of 2 foot-candles

Inside the lobby

- 0 to 5 feet = Minimum of 10 foot-candles
- Minimum of 2 foot-candles inside each lobby entry

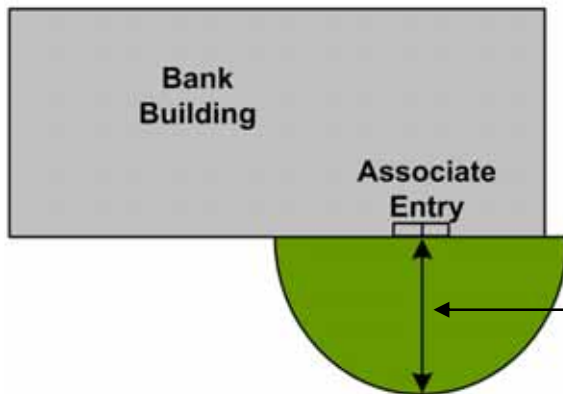
Associate Entrances

The associate entry is the main entry used for opening and closing procedures

From the entrance door outward

- 0 to 10 feet = Minimum of 2 foot-candles

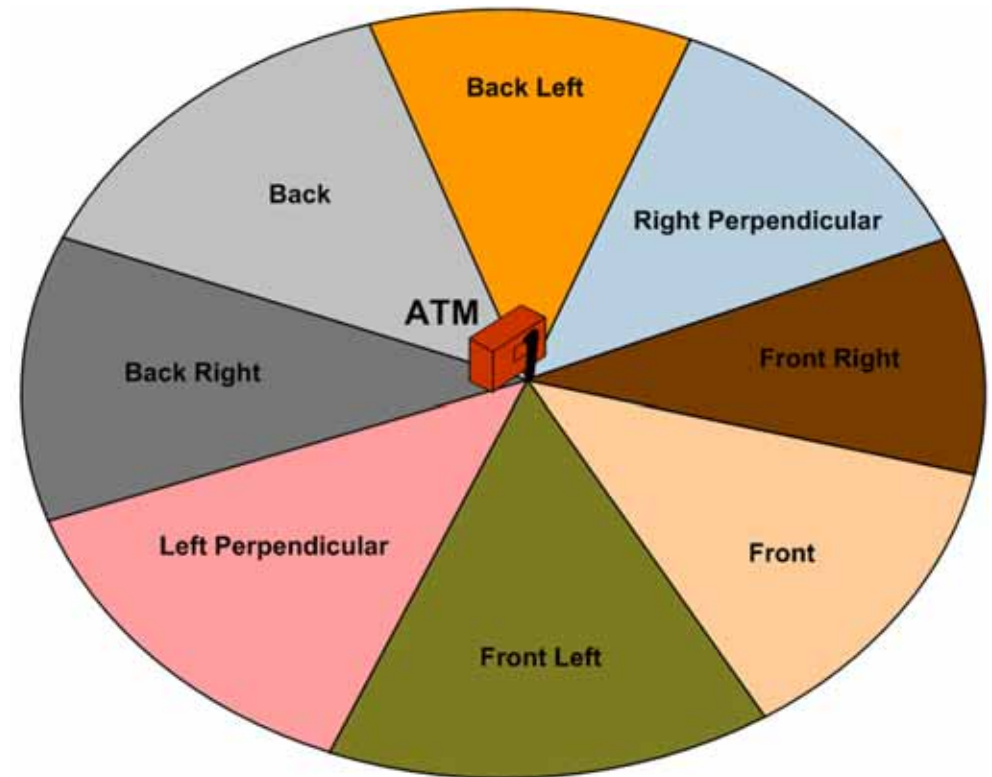
- Bank of America and GMR have agreed on a predetermined set of testing points designed to sample lighting levels throughout the access area in an even and repeatable manner
- The sampling area is circular. We divided the sampling area into “slices” to establish a consistent pattern throughout the access area

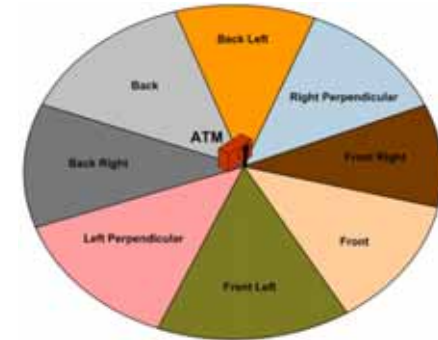
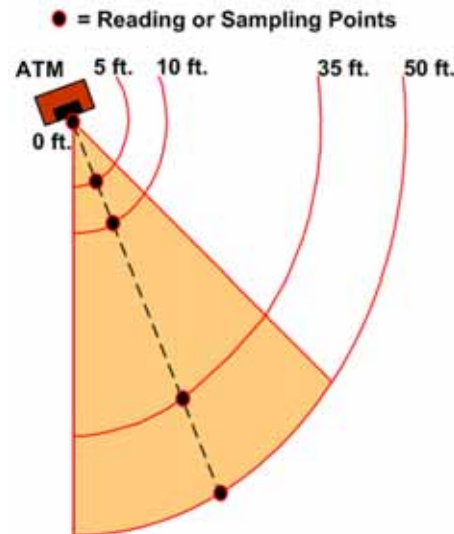
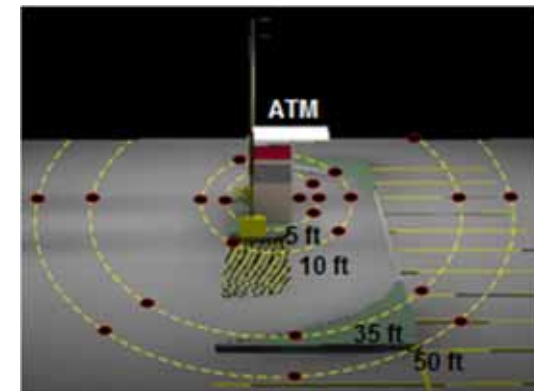
- We sample at certain distances within each “slice” resulting in an even distribution of sample light readings and repeatable sampling methodology
- GMR samples at:
 - 0 feet
 - 5 feet
 - 10 feet
 - 35 feet
 - 50 feet

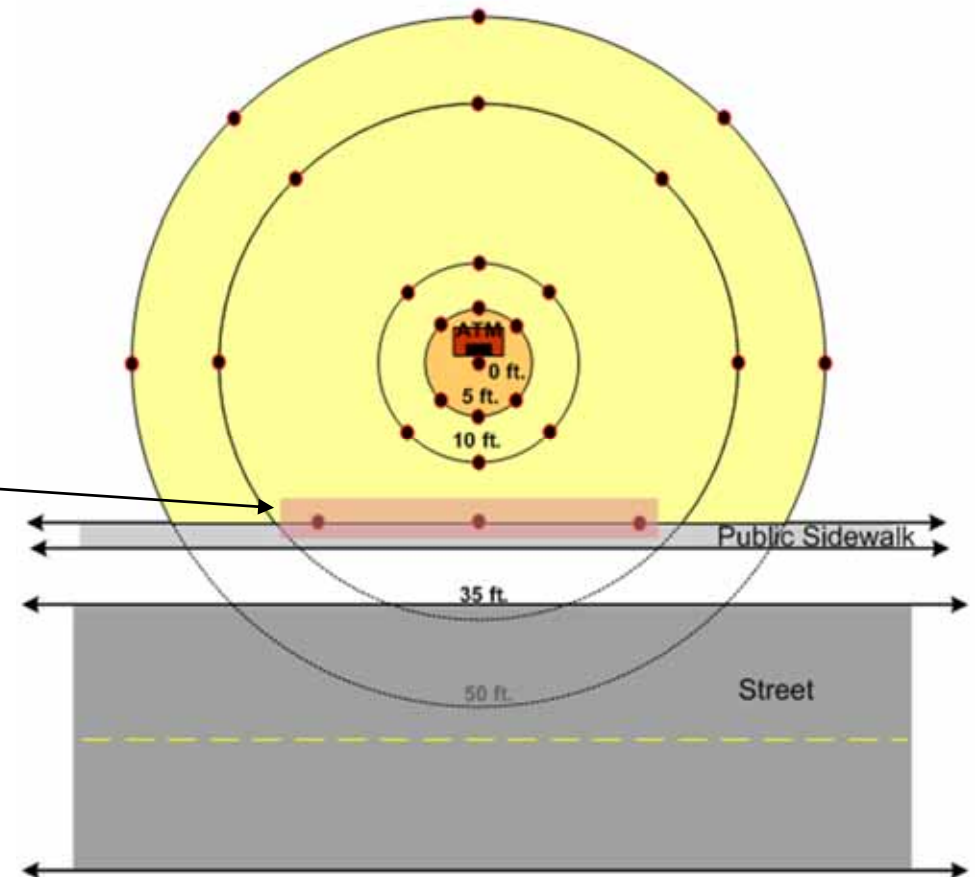
- GMR will adapt the predetermined reading pattern to accommodate property lines, streets, sidewalks or permanent obstructions
- In the example to the right, GMR would move the reading points in order to accommodate a public sidewalk

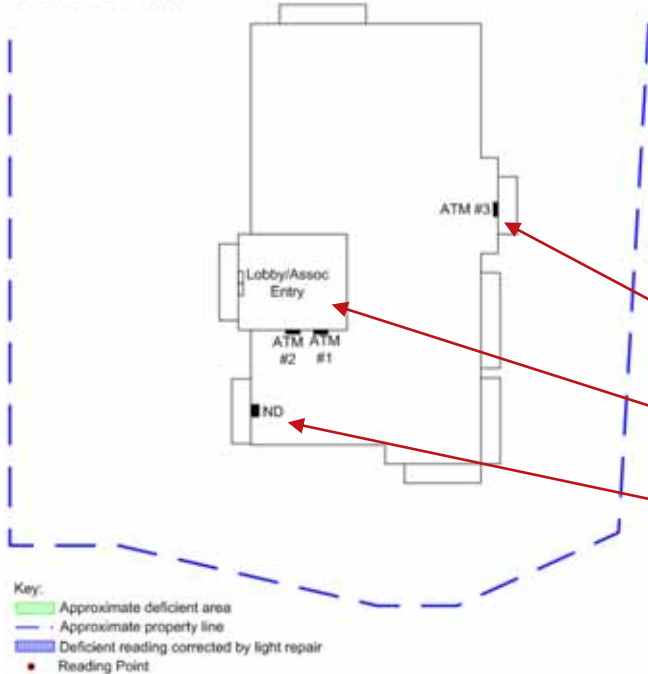
Overhead View of the Site

Scope of work for GMR Design and Lighting Survey:

- There are three exposures (things to be designed for and surveyed) at this location:

- ATM - Thru The Wall
- Lobby containing 2 ATM's
- ND - Thru The Wall

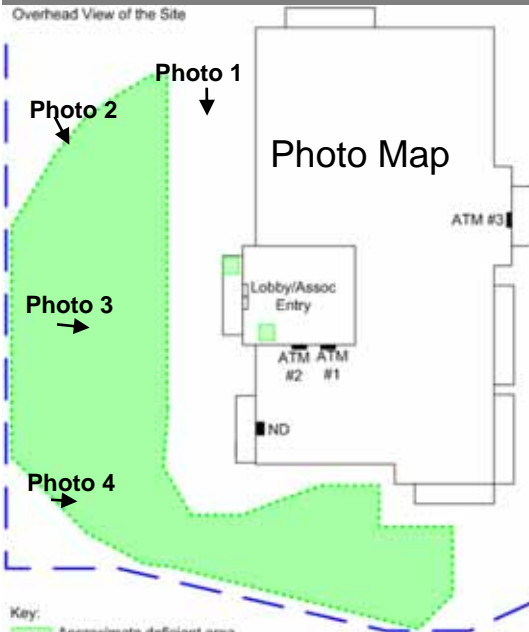
Overhead View of the Site

Key:

- Approximate deficient area
- Approximate property line
- Deficient reading corrected by light repair
- Reading Point

- Address landscaping issues (e.g. reduce height, remove or refresh landscaping)
- Install new fixtures as noted on drawing
- Upgrade existing fixtures as noted on drawing

- Install a 5 foot tall iron fence (approx. 75 feet long), as noted on drawing, to shrink the access area and reduce risk
- A fence is used at this location, in part, due to the drop in grade along the front side of the ATM

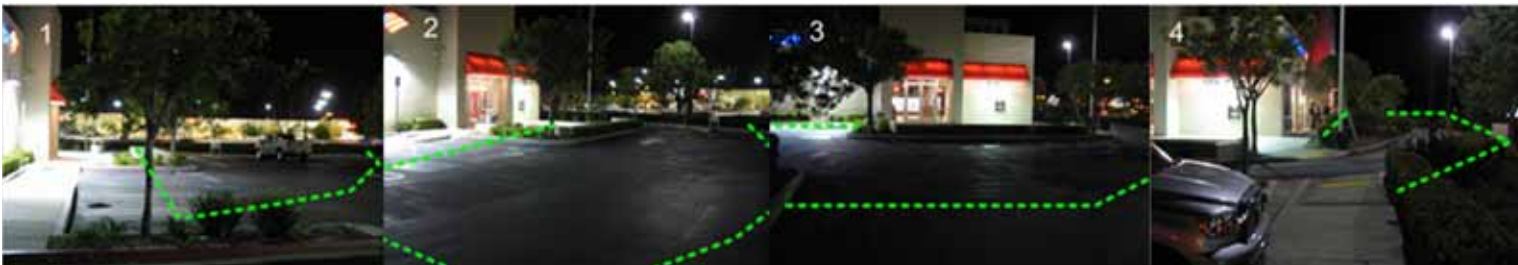
Photos and reading boxes illustrating the deficient areas:

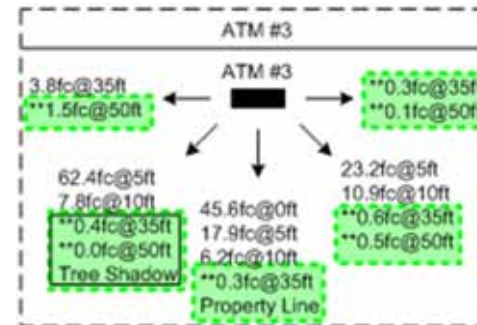
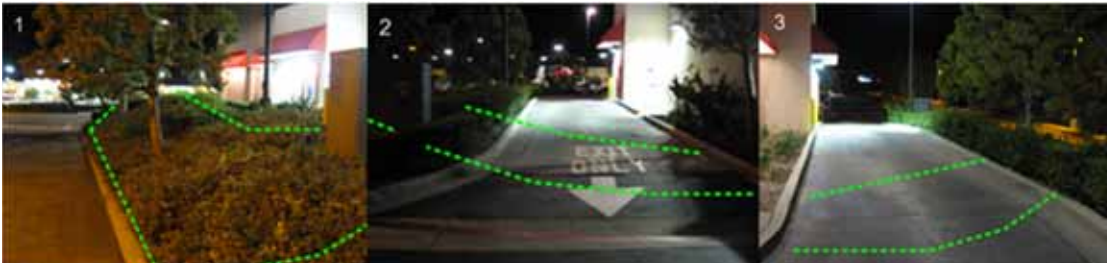
Photos and reading boxes illustrating the deficient areas:

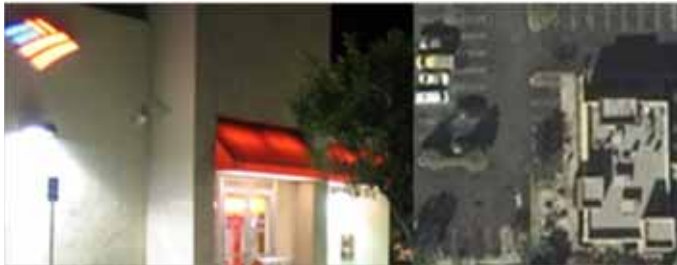
Possible solutions:

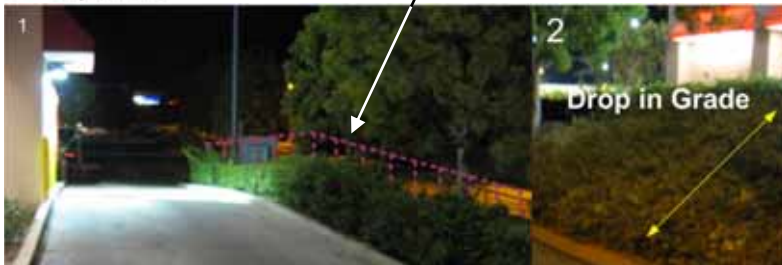
Possible solutions:

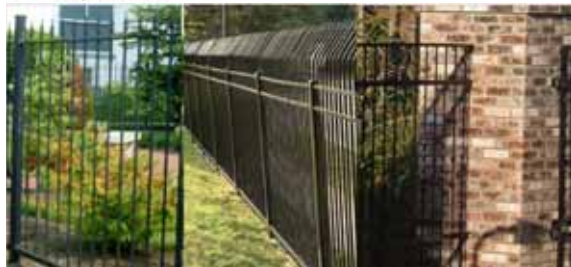
Possible solutions:

- Fences should be used very selectively
- Generally fences in this type of application should extend 30 feet in each direction from the centerline of the ATM or ND
- Generally fences in this type of application should be at least 5 to 6 feet tall from ground level
